# Sorell Council Southern Beaches CERMP Outfall Project

## Outfall Project 2\_SE115466

**763 Primrose Sands Road  
Anna Wilson October 2023  
V2.0  
25/01/2024**

## SE115466 Project Brief

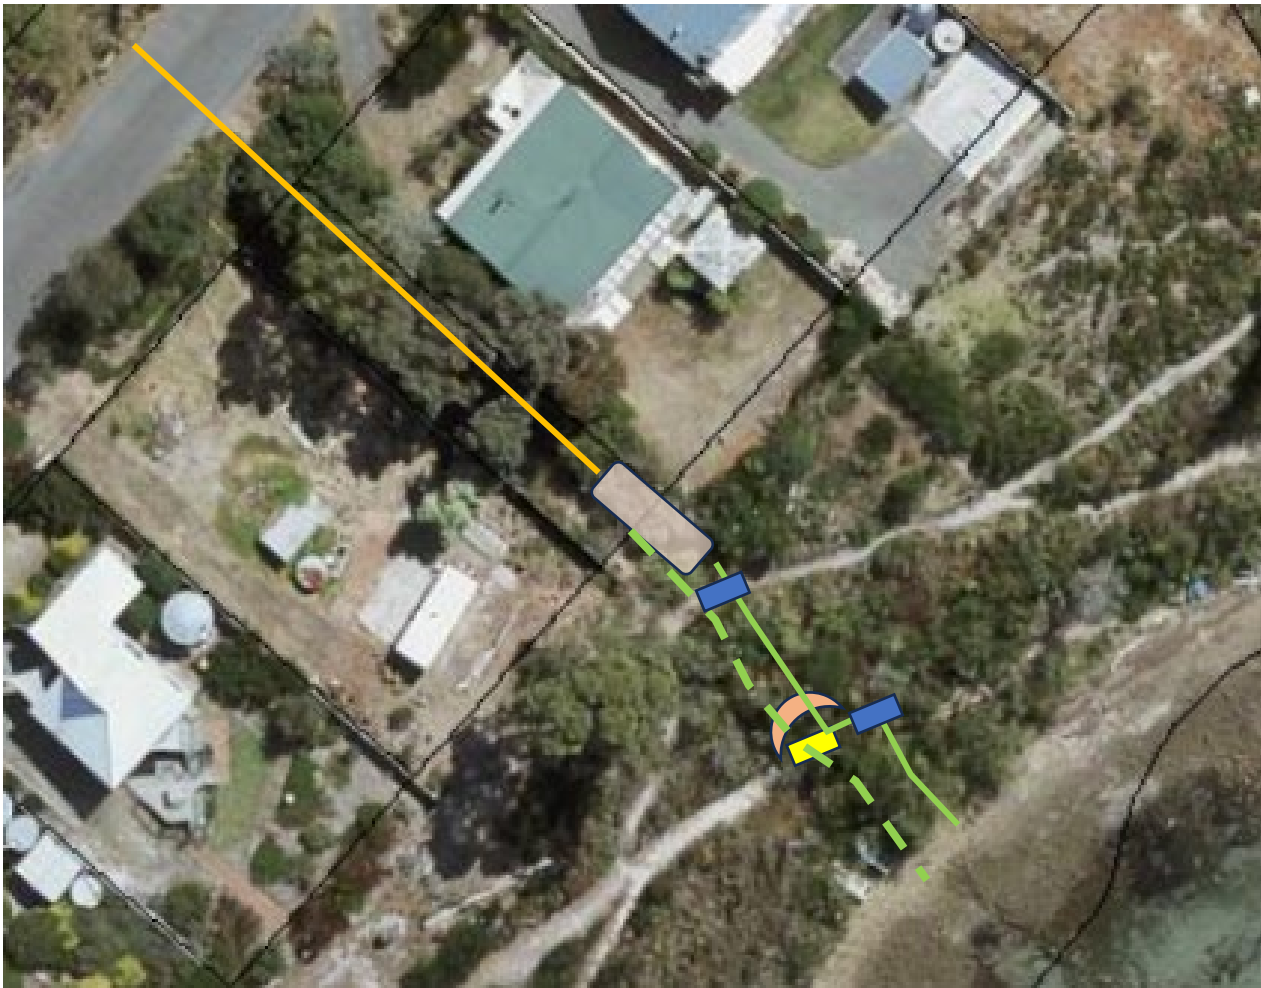
Inspection of this outfall determined a number of elements at this location

- 450mm dia pipe
- Erosion gully
- Wooden boards to cross
- Old culvert – rock endwalls
- Erosion on bank
- Previous flow path
- Current flow path

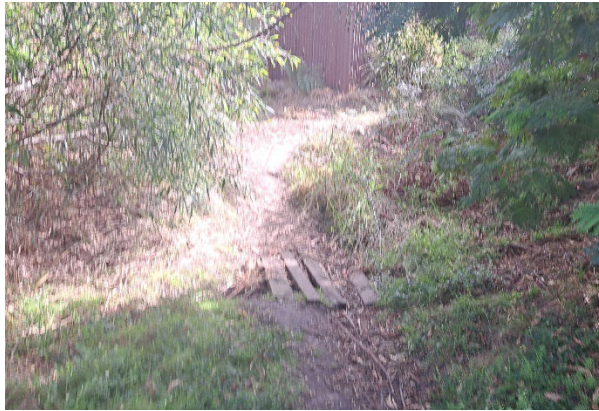
No.	Issue	Notes	Image
OP2.I1	Erosion gully forming at existing outfall	Outfall at a random location upstream of walkway approximately $\frac{3}{4}$ of the way down access track. Outfall area covered in vegetation.	
OP2.I2	Boggy area at first walkway crossing	Crossing is some planks to get over boggy area. This is an informal structure.

No.	Recommendation	Notes
OP2. R1	Extend pipe section and install headwall	Install rip rap to reduce velocity at headwall
OP2.R2	Divert trail over new pipe.	Remove existing planks / bridge.
OP2.R3	Erosion management	<p>The area of erosion upstream of bridge two must be battered back and topsoiled. The topsoil should be lightly compacted, planted and seeded and covered with a jute mesh for plant establishment. This should prevent future erosion in this location.</p>
OP2. R4	Clear out existing culvert and keep existing secondary flow path.	<p>Looking at previous imagery (pre 2000 ListMap) the walkway extended directly downhill as shown. This likely led to significant erosion issues that have been effectively mitigated by redirecting the foot way and the flow path.</p> <p>The existing culvert may have been left to block and the flow diverted under the newer small wooden bridge to assist with the remediation of the original erosion. The area through here now is densely vegetated and appears to have remediated well.</p> <p>The recommendation is to clear out the existing culvert and keep the newer flow path as back up.</p>

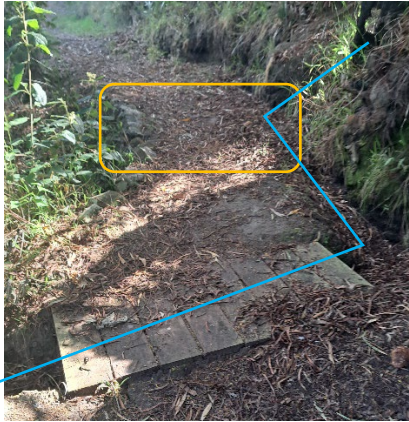
<p><b>OP2.I3</b></p>	<p>A. Boggy area at second walkway crossing</p> <p>B. Blocked culvert at second crossing</p>	<p>There is a small wooden bridge to get over the boggy area here.</p> <p>There is also an existing culvert that is blocked (orange) and covered in soil.</p> <p>Current flow path shown in blue</p>

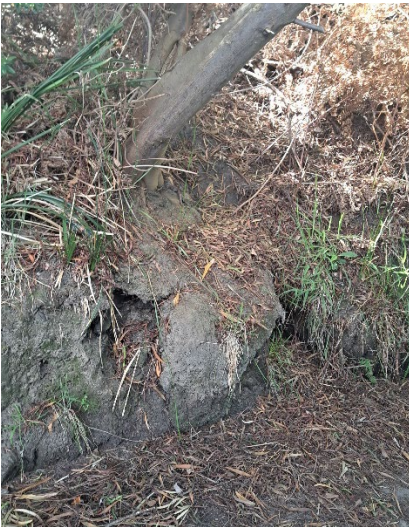
<p><b>OP2.I4</b></p>	<p>Erosion at second crossing</p>	<p>Erosion in the uphill cut of the second crossing.</p> <p>There are some small tunnel type erosion forming at this cut in a number of locations.</p>

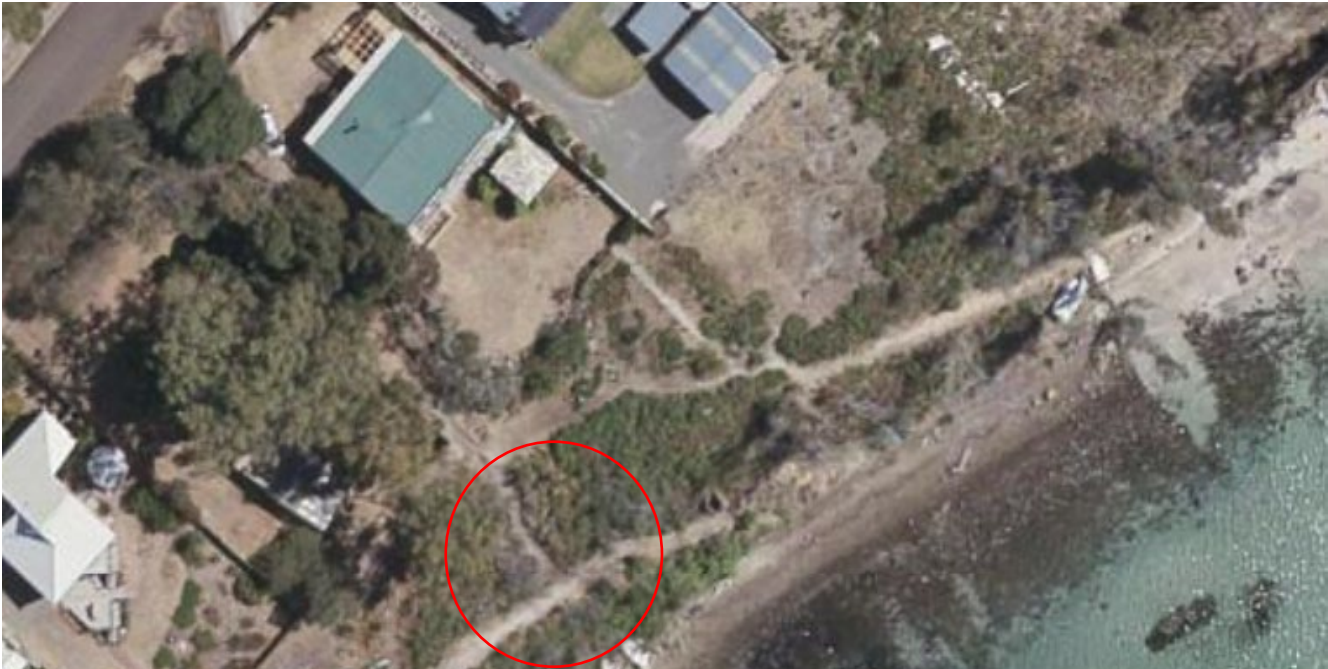
Figure 2 Pre 2000 Aerial photography showing old walkway location

This outfall is relatively straightforward. There is a small area of significant erosion upstream of the first walkway, an area of recovered erosion and two crossings. Previously the flow path was down a walking path along the line of the previous flow path. This has previously been addressed and appears to be regenerating well. The
