# Sorell Council Southern Beaches CERMP Outfall Project

## Outfall Project 4\_SE115474

56 Grevillea Street  
Anna Wilson December  
2023

### SE115474 Brief

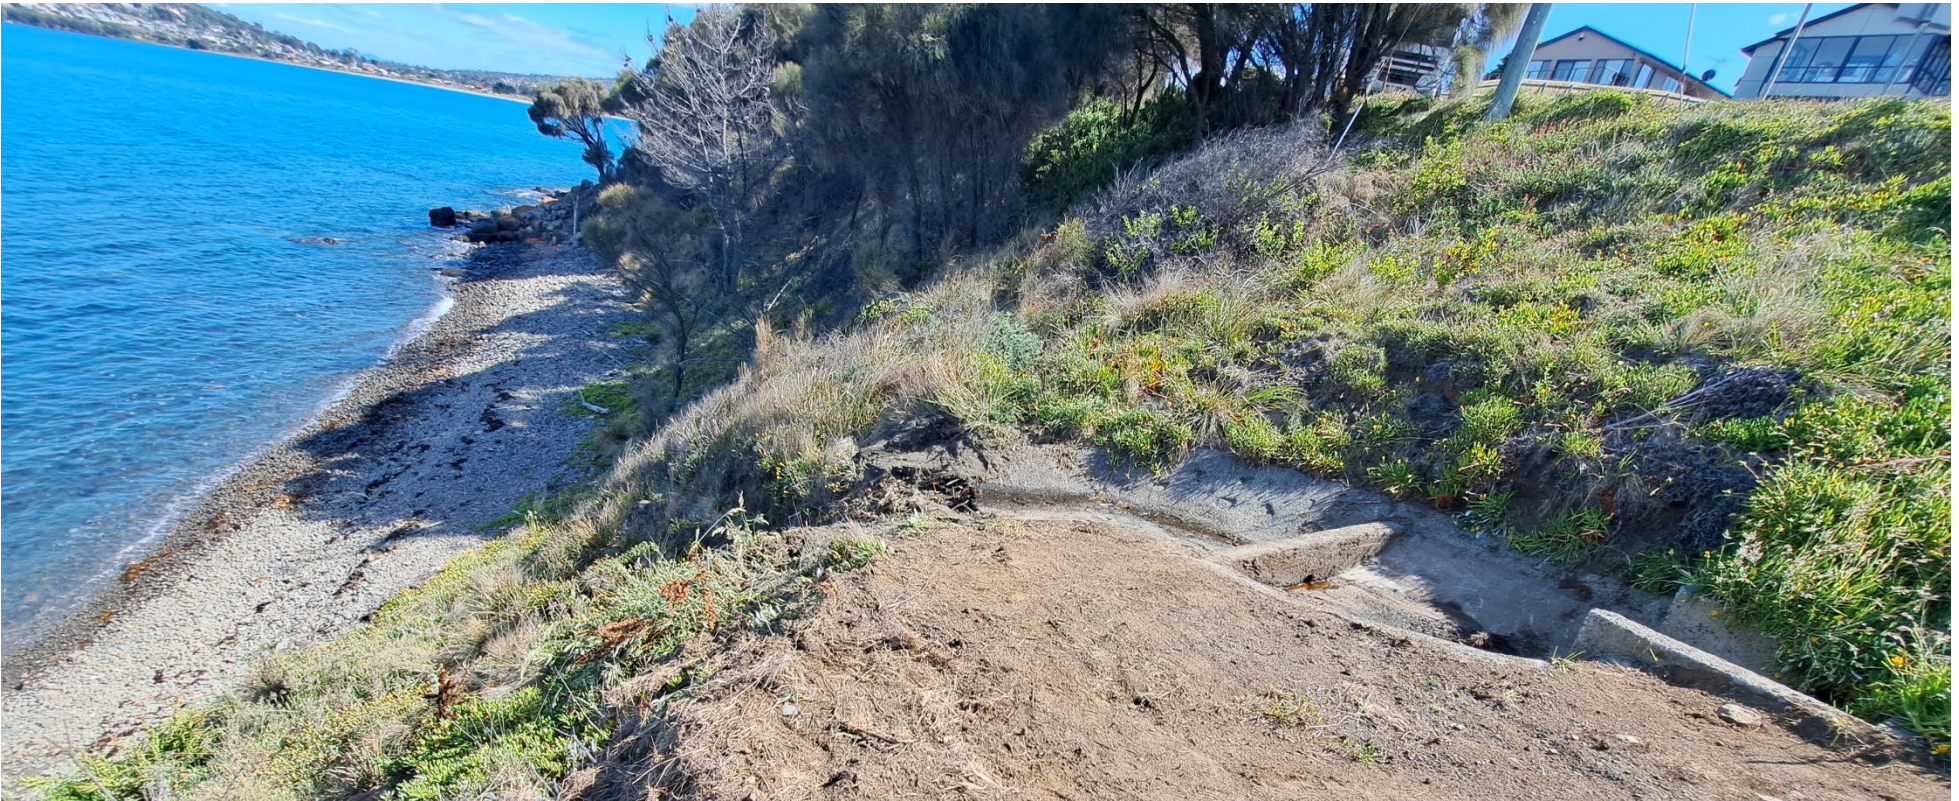
Figure 1 Existing arrangement top view

The existing outfall is a 525mm dia pipe that outfall into a formed concrete channel prior to dropping off onto the unmanaged slope then outfalling onto the pebbly beach.

The channel is constructed at a cross slope angle to the pipe outlet. The channel is approximately 3m long and outfall approx. 10m above the beach line.

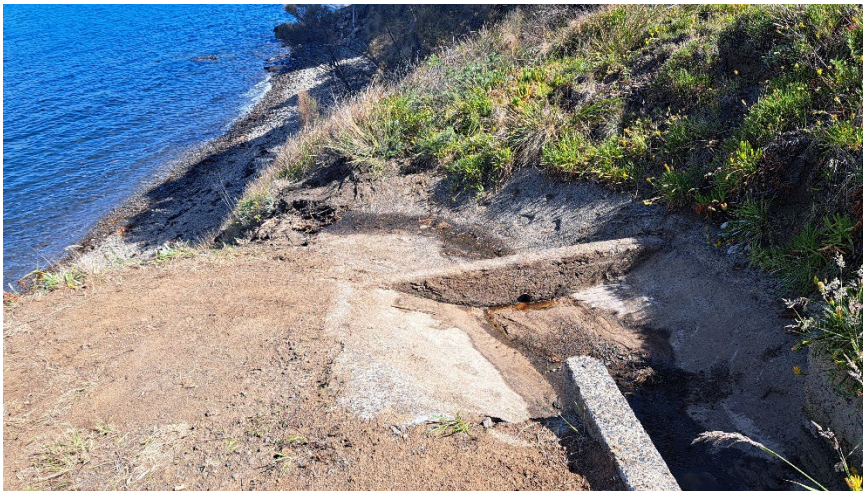
Figure 3 Detail of current outfall arrangements

A significant erosion channel has formed between the concrete outfall and the beach due to the high energy the water regains rapidly after leaving the existing energy mitigation arrangement.

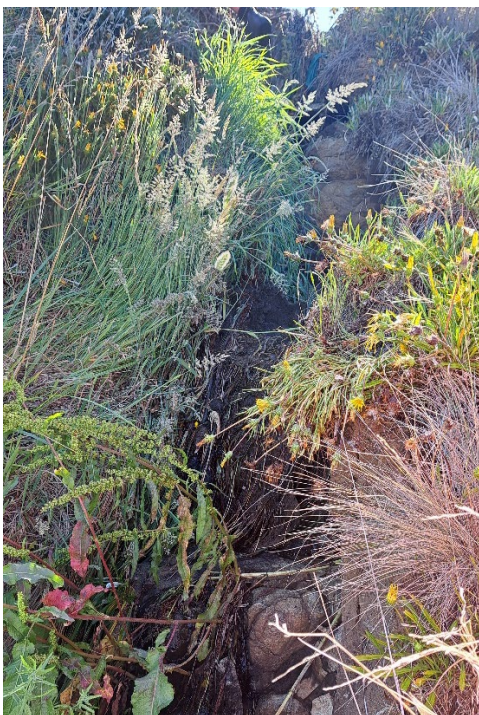
Figure 4 Detail of erosion channel

In several areas the gulley appears to have eroded to bedrock.

- A vegetated solution, even if supported by the best geotextiles, may fail as the slope and channel velocity exceed what is recommended.
- A hard base is required to mitigate further erosion
- Whilst there are some areas where the channel is eroded down to bedrock this does not extend for the length of the channel. The areas that are not bedrock are actively eroding and increasing in depth. Inspection showed these areas to be the most vertical.

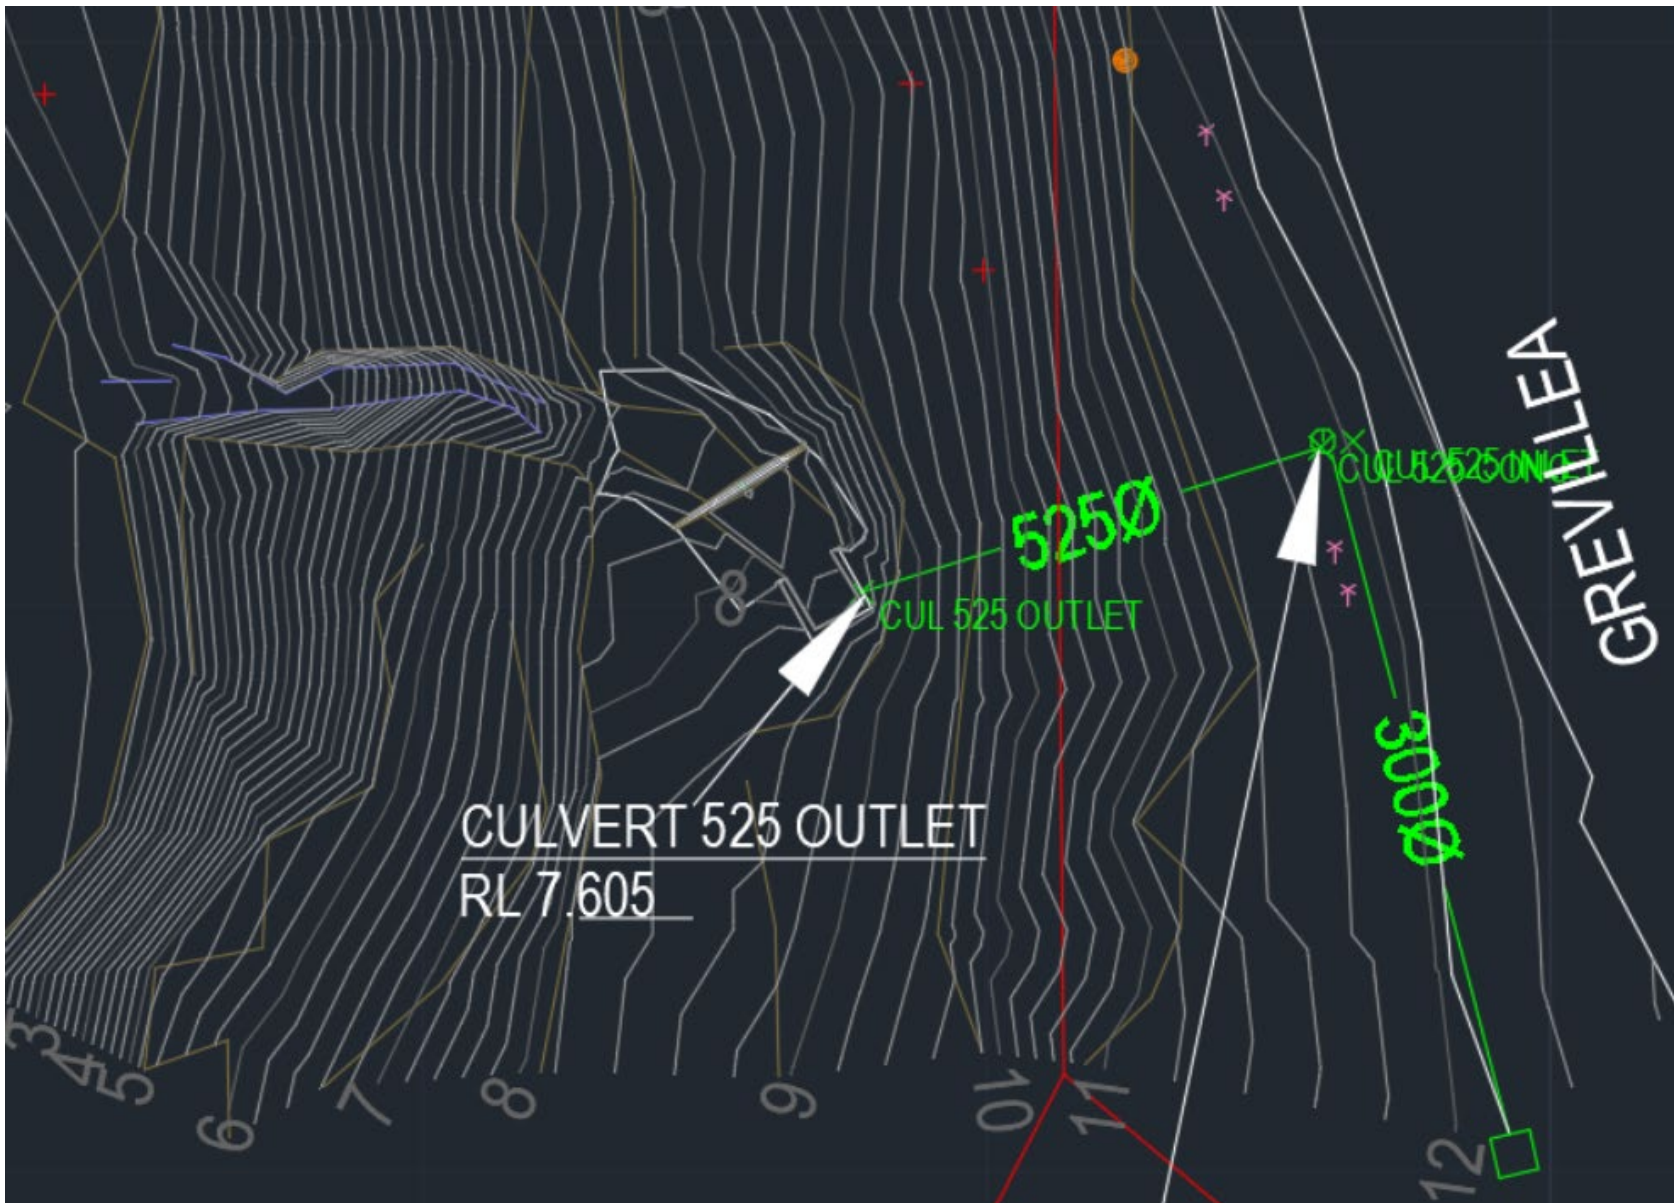
Figure 5 Survey detail of existing conditions

This location contains a steep grade which is likely why there was not erosion management down the slope at the time of construction. The survey of the site revealed the following grade of the channel (magenta). Subsequent site inspection indicates that there may be sections of the

channel approaching vertical, it is possible the survey did not accurately pick up the base of the channel. An estimation of the possible channel base has been shown in white.

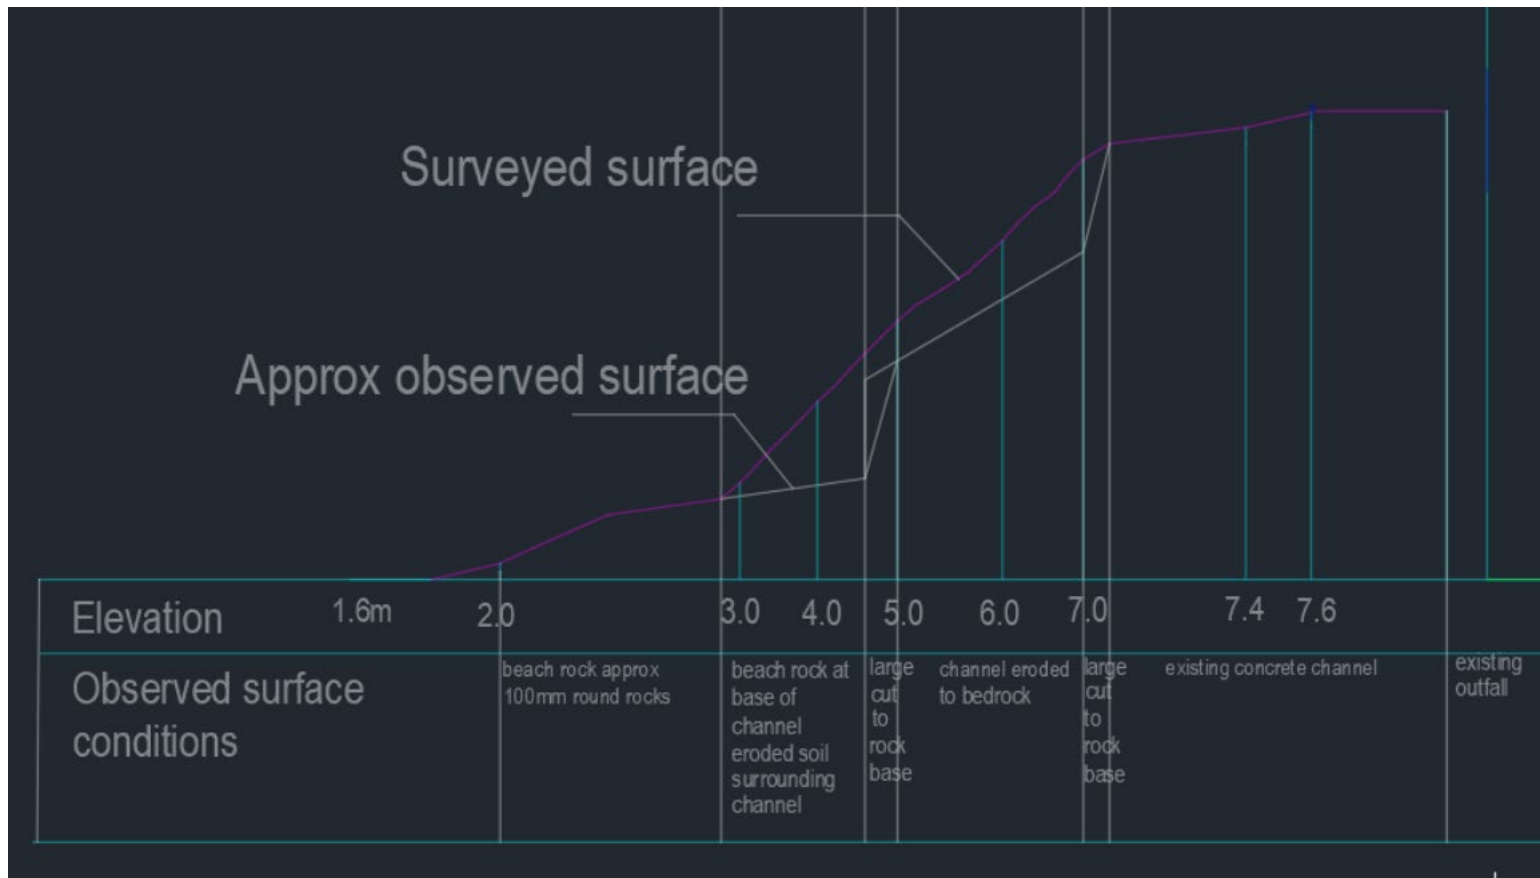
Figure 6 Detail of Survey cross section showing surveyed grade and possible actual grade.

The surveyed grade is approximately 1:1 through the central section.

This grade creates a number of issues:

- Rapid increase in velocity and energy past the dissipator.
- High velocities will be impossible to mitigate at this site given the required fall.
- Access difficulties.

The recommended solution in this location is to extend the piped network to the shoreline. This option ensures that the water stays effectively contained minimizing future erosion risks.

- Remove existing concrete channel and create machine pad for works
- Excavate pipe location using either:
  - Dam excavator – this should reach to base
  - Chain anchored machine – to be determined by operator.
- Install PE pressure sewer pipe – this pipe has a higher resistance to scour than standard stormwater pipes so is recommended for this application.
- Bed pipe in concrete, pump in no mesh required as per AS/NZS 2566.2:2002 section 5.8.3.
- Place large concrete cattle trough -.45m OD at base of pipe as an energy dissipater. Face 2inch outlet toward beach.
- Concrete endwall connecting pipe end to tank.
- Surface to be reinstated with local material or imported topsoil. Seeded with local grass seed mix and covered with double layer of jute mesh anchored at 1m centres.
