Sorell Council Southern Beaches CERMP Outfall Project

Outfall Project 5_SE112501

First Avenue Anna Wilson December 2023

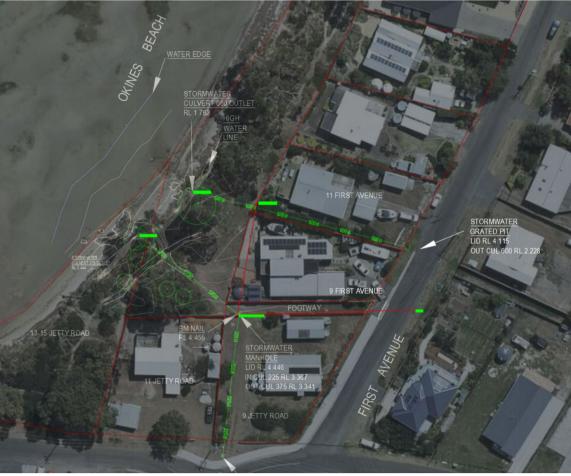
Figure 1 Survey of First Ave investigation site.

The entrance to Okines beach contains two stormwater pipe outfalls, a 600mm dia pipe to the north discharging onto the beach at RL1.763 and a 375mm dia pipe (SE112501) discharging to the south of the access steps halfway up the erosion cut at RL 2.44.

The embankment surrounding the access has eroded out to a vertical wall and is collapsing around the entrance and outfall.

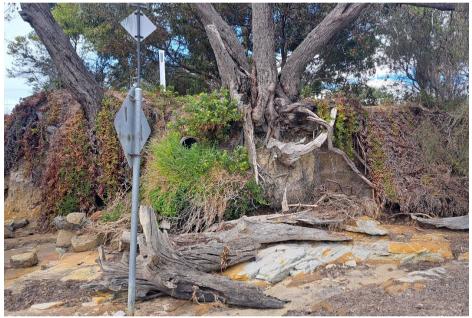
Figure 2 image of outfall SE112501

Site analysis shows that the stormwater outlet is not the cause of the erosion at this site. The erosion is coastal and is caused by continued wave motion against the base of the embankment. The erosion has caused the slope to become too vertical for vegetation to grow on and has therefore lost protection from the wave energy.

Under this scenario the erosion will continue to push back the unprotected vertical face by eroding the base of the face and causing the top of the face to eventually collapse. The collapse, if significant enough, may stabilise the face if a shallow grade embankment is created which is stabilized by plants.

The recommendations are to manage the coastal erosion impact and stabilise the embankment. Note that coastal erosion is a natural and constant impact on coastal areas. Requiring that the embankments stabilise to suit existing urban development will require management.

- Concrete hard rock—sound dolerite, basalt or granite, boulders of increasing size to the edge of the existing rock platform to act as a toe for the embankment.
- Remove the two casurina trees overhanging the embankment
- Batter the embankment down to the rock toe. Batter back to no steeper than 1 in 4 slope..
- Compact batter and cover with jute mesh for stabilisation whilst plants establishing
- Remove approximately 2.4m of existing stormwater pipe to bring pipe back in line with new batter.
- Place headwall at end of existing 375mm dia culvert
- Rock pitch drain from culvert to rock toe.
- Plant embankment at 300 centres with a mix of the following: Total plant area approx. 55m2 – additional planting may be required for site disturbance.

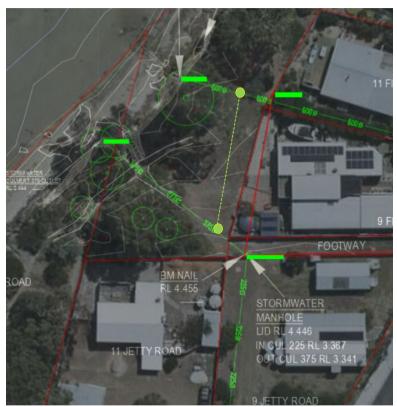
Figure 5 Existing infrastructure showing possible stormwater link

Given the existing levels it is possible to consolidate the outfalls at this location. This would involve installing two new manholes and extending the 375mm line through to the 600mm line as shown.

- Each outfall is currently able to handle its stormwater load without causing problems. If you increase the load at outfall SE112502 it may increase the flow enough to trigger erosion problems.
- The load on 600mm dia pipe at SE112502 is likely to increase under future development scenarios. Diverting the 375mm dia pipe may increase the flow beyond an acceptable level
- The outfalls are not in high risk zone for pollution. The largest driver of pollution in this location is Old Forcett Road, the 375 mm dia line catchment area is small and residential only. It does not appear to contain noticeable pollution levels.
- A possible green treatment option was considered for this site between the dwellings and the coastal embankment. This is unlikely to be successful in this location as the existing 600mm pipe is 2m below surface levels.

At this stage I recommend not pursuing consolidation at this location for several reasons:

This option may be reconsidered when or if Lot 1 Od Forcett Road is developed and flows into the 600 dia line can be quantified. If this lot is developed and puts extra load into this location, and
