Sorell Council Southern Beaches CERMP Outfall Project

Outfall Project 3_SE115527

189 Lewisham Scenic Drive Anna Wilson December 2023

SE115527 189 Lewisham Scenic Drive Existing conditions

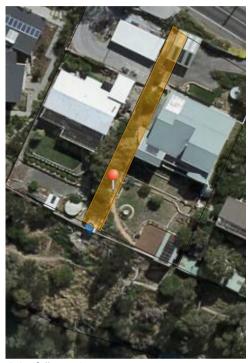
Figure 2 Outfall Location

The outfall SE115527 is at the back boundary of title 112209/1 - a designated but unused footway – and 189 Lewisham Scenic Drive. The outfall is a 225 dia PVC pipe of varying grade collecting stormwater from 1 side entry pit on Lewisham Scenic Drive. The pipe does not appear to be in Councils mapping system.

The existing outfall falls at the rear of the property boundary with approximately 23 metres of overland flow and 13.8m of fall prior to water level. The flow crosses a small footway at approximately 10m

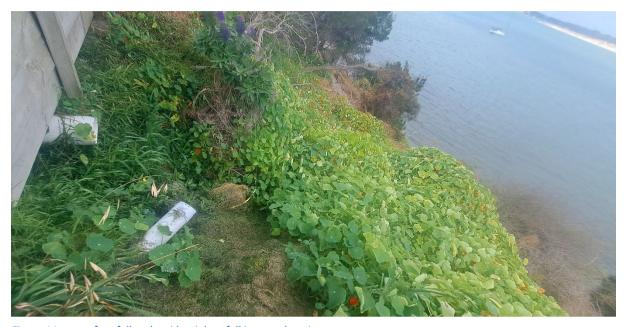
Figure 1 Image of outfall and residential outfall in same location

- Erosion occurring at the outfall
- Walkway is affected by water muddy sections- however is holding up with no erosion.
- No apparent erosion downstream of the walkway.

The erosion at this site is at a nuisance level rather than a significant risk or threat. The outfall location itself has some erosion and the outfall is freestanding in the air however this is partially due to the level of fill in 187 Lewisham Scenic Court rather than entirely due to erosion from the outfall.

The recommendation is to install a PE sewer pipe from the outlet to a slightly flatter section just below the footway and installing a dissipator TEE junction (Washington State Department of Ecology, 2019) at the new outfall.

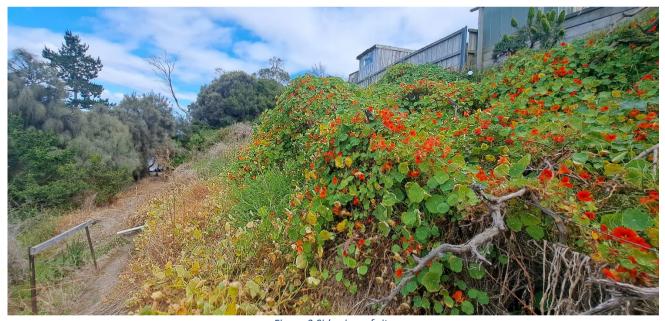
Figure 3 Side view of site

Due to the profusion of weeds it is difficult to tell how far down the existing erosion goes but there is no erosion present at or below the walkway. It appears that the existing vegetation is providing protection to the soil from erosive forces.

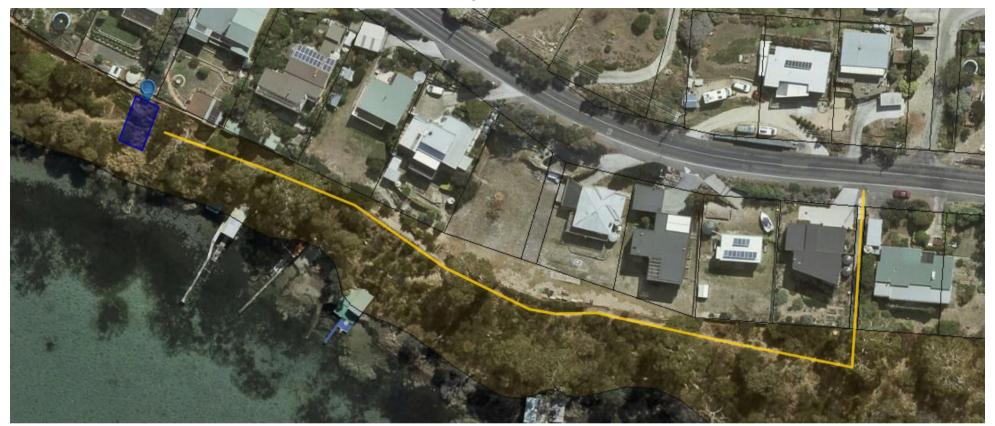
Figure 4 Access Route

13.	Limited Access	There is walkway access to the site. It is possible that a very small machine may be able to
		access the site, otherwise any construction at this site will have to managed by hand
		equipment only.

Access to the site is difficult and most machines will not be able to access the site. The site works will need to be carried out predominantly by hand with some small motorized machinery to assist if possible. The proposed design takes this issue into consideration.
