# Southern Beaches Recreational Water Quality

# Annual Report

2024-2025

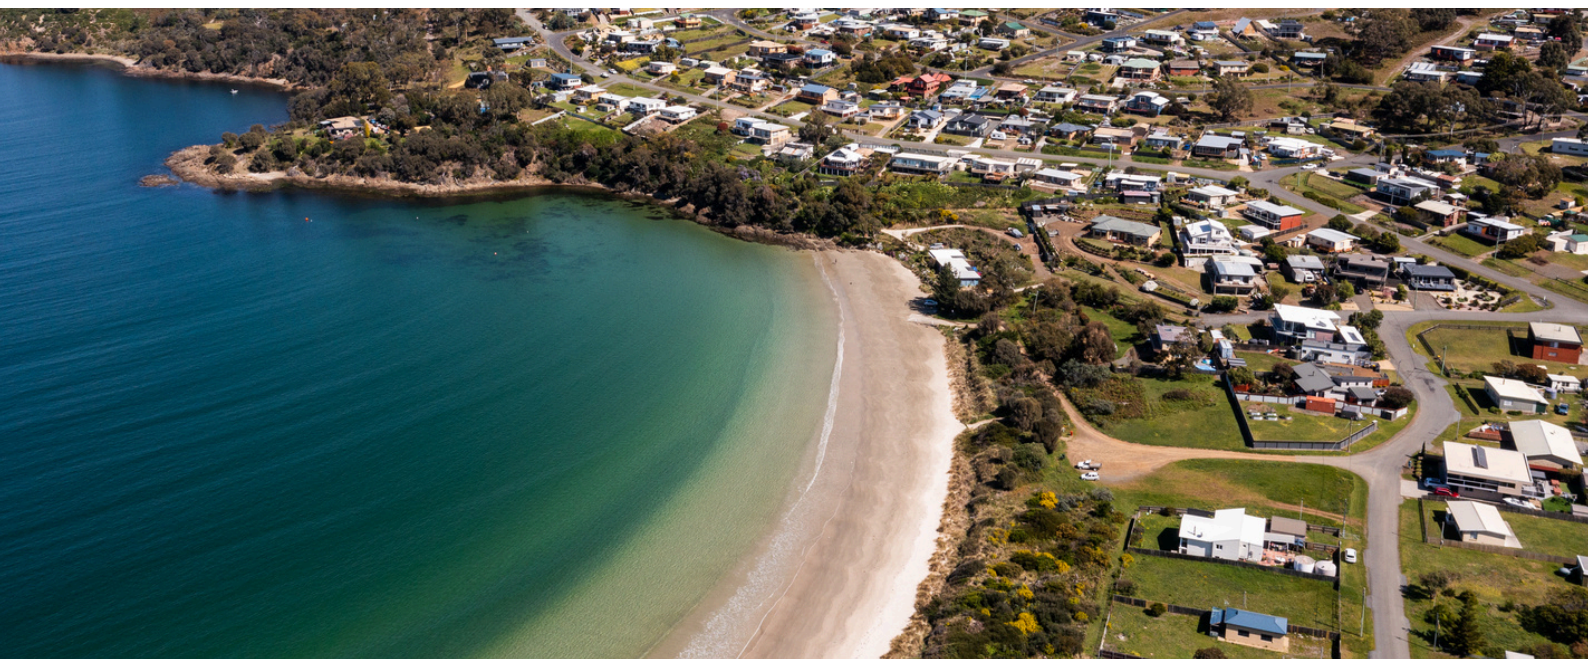
Table 2 Sanitary survey of all beaches

Location	Sanitary Survey Risk	Risk
Connellys Marsh Beach	Minimum of 10 Boatsheds, yacht moorings, onsite wastewater management systems (OSWMS) on nearby properties, river at southern end of beach running through heavily grazed farms with livestock grazing within the riparian zone and river proper.	**Moderate-high (trending towards low risk)
Primrose Sands Beach	Potential failing OSWMS above western end of the beach, active landslip along the foredune of Carlton Bluff Road, vehicle movement on beach (prohibited activity), concentrated ground water seepage and old stormwater infrastructure.	Moderate -poor
Primrose Sands Beach Shop	OSWMS above dune area Onsite Waste management systems, carpark, dogs, stormwater outfall.	Good (first season)
Primrose Beach mid beach	Remnant vegetation on private land on the foredune, wetland lagoon nearby, OSWMS from houses on the foredune.	Good (first season)
Park Beach Carlton	High density OSWMS large dune system for protection against seepage, toilet block nearest to sample site. High energy beach	Low

Red Ochre South Beach	Stormwater outfalls: birdlife habitat protected area Spectacle Head, boatsheds, gravelly beach, higher density housing with OSWMS, greater threat of nutrient enrichment from OSWMS	High
Red Ochre North Beach	Bird life, OSWMS, medium density housing Spectacle Head a known rookery for shorebirds. Blue lagoon in the back of the dune and playground.	Moderate
Tiger Head Beach (Seventh Ave)	Large Stormwater outfalls, unsewered area, high density residential with Onsite waste management systems.	High
McKinly St Midway Point	Large stormwater outfalls onto beach, Orielton Lagoon RAMSAR wetland protected area. Highest density urbanisation with increased gross litter being washed into waterway. Hard surface land clearing. History of sewerage failure from pump station situated above the beach.	High
Blue Lagoon	Secondary contact point monitoring for stormwater quality	High

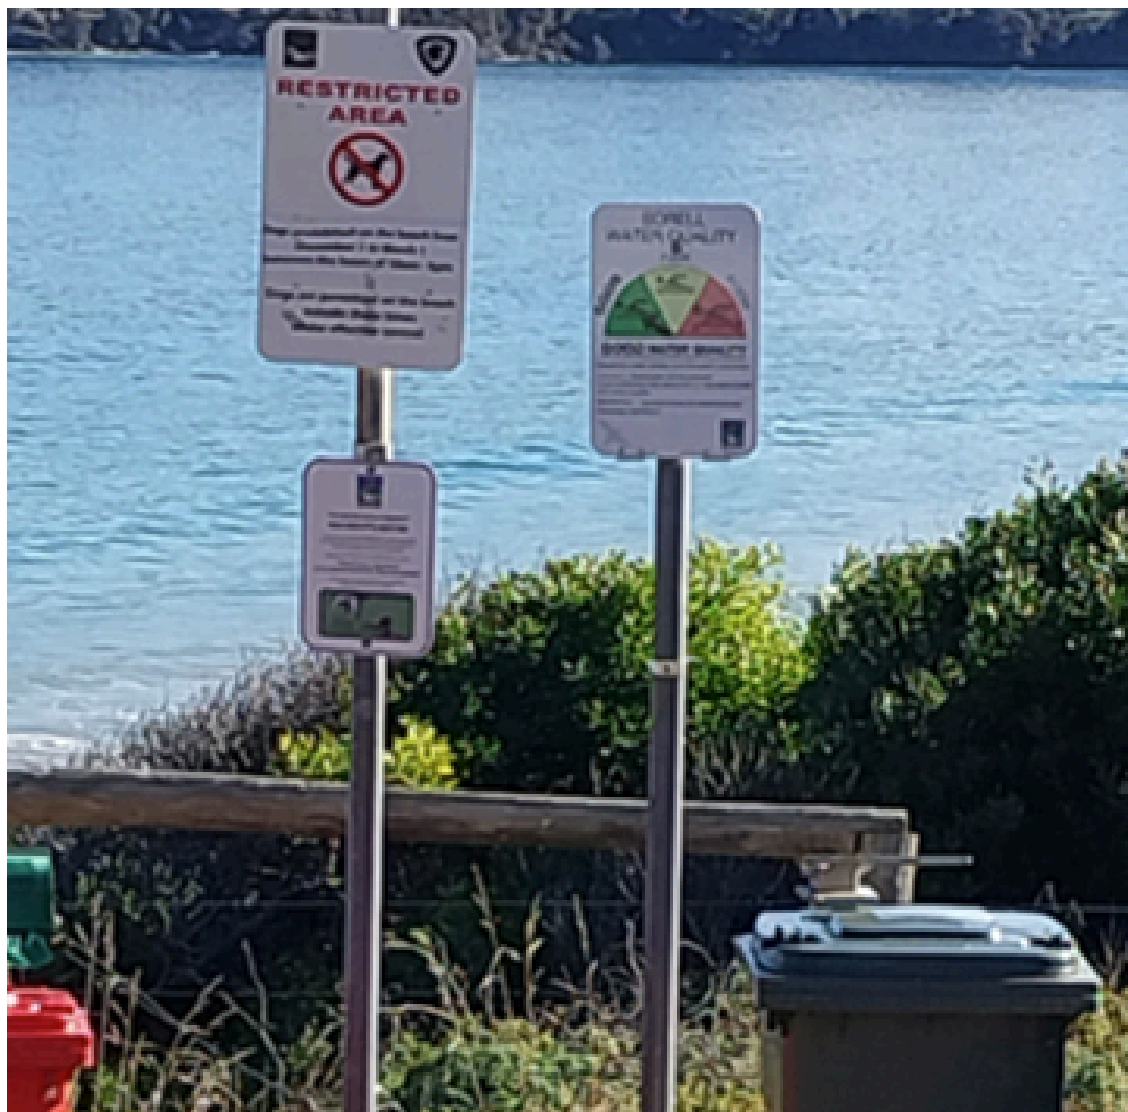
Figure 2 New installed RWQ sign at the Southern end Primrose Beach (Shop).

Table 5 uses a rolling five-year dataset for determining the 95<sup>th</sup> Hazen percentile. As determined by NHMRC and Tasmanian Recreational Water Quality Guidelines. Statistical analysis performed on the water quality of the sites showed three of the seven beaches slightly declined in water quality while three sites remained stable. One site Primrose Beach (Boat Ramp) rapidly declined to change from good water quality to fair for the 2025-26 season. The additional two sites on Primrose beach could not be statistically analysed, however, only one exceedance occurred at both additional Primrose Beach sites this summer. Therefore, both sites are ranked 'good' for 2025-26 to reflect results of the sanitary survey. Due to the 95<sup>th</sup> Hazen Percentile being determined over a five-year rolling data set, the new sites will be included for Primrose Sands and as such Council has installed an additional recreational water quality alert sign at the southern end of Primrose Beach (figure 2).

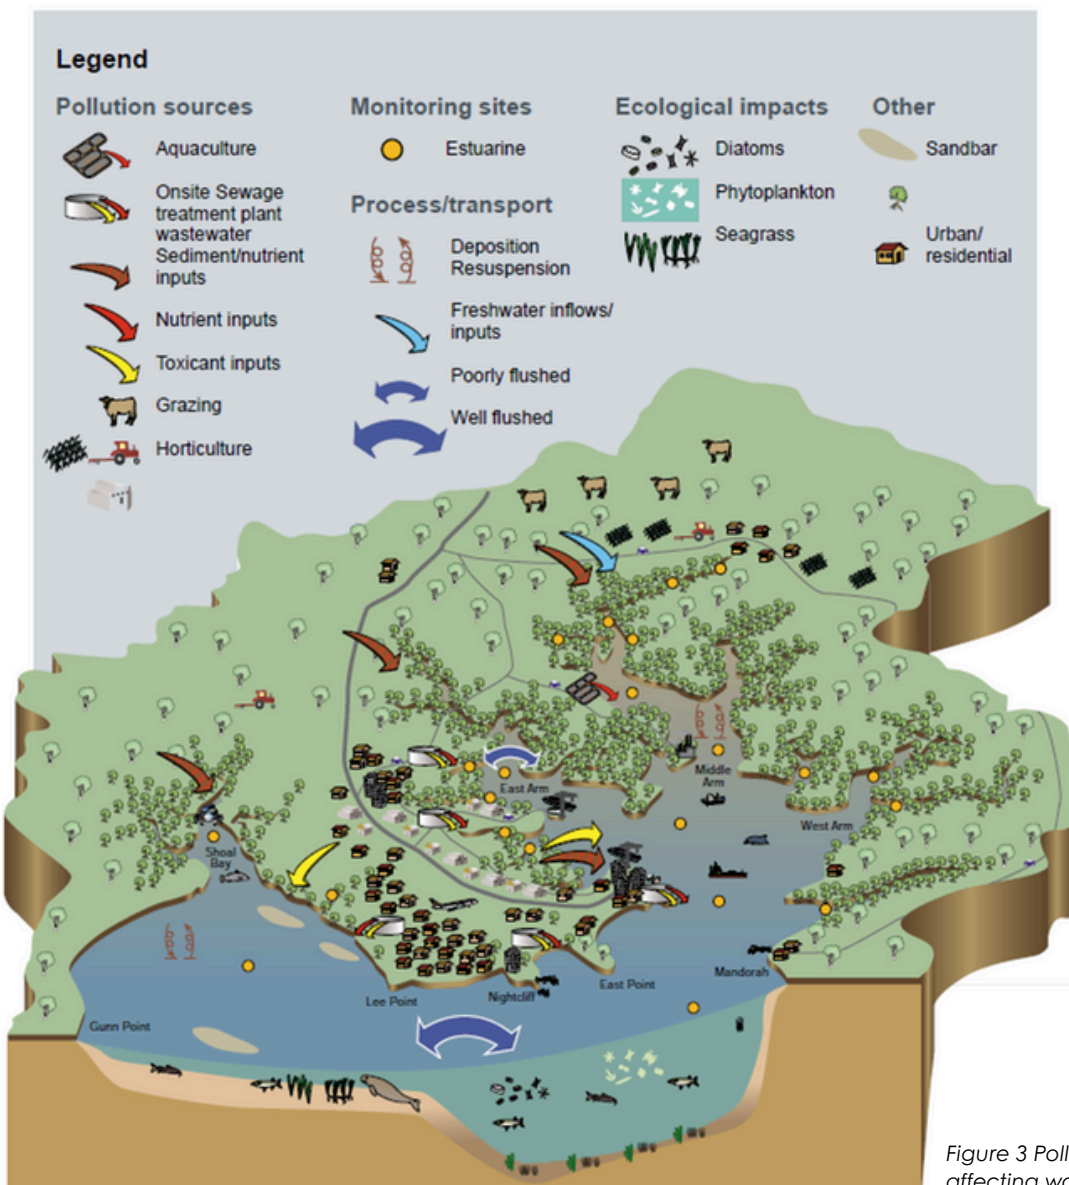
Figure 3 Pollution Sources affecting water bodies source;

The catchment areas of each of the Southern beaches sampling sites (excluding McKinly St, which is serviced by reticulated sewerage) contain significant numbers of septic tanks and other on-site wastewater management systems. Some of which suffer varying levels of malfunction during periods of wet weather. Stormwater systems or creeks may convey pollutants discharged from on-site wastewater management systems to beach areas. Stormwater outfalls discharge in the vicinity of each of the recreational sampling sites, except for Park Beach. Figure 3 shows multiple factors that influence the quality of our recreational Water quality.

Dodges Ferry Lagoons, TasWater commissioned a Dodges Ferry Sewerage Technical Due Diligence Report in 2018. The report investigated the current status of the lagoons. This included the potential impacts from the 25yo sewage lagoon system to environment and public health. One finding concluded that a 'relatively high' risk of seepage within the underlying aquifers can potentially cause groundwater contamination and therefore increase the risk of pathogen contamination in nearby recreational waters. Increased nitrification has been recorded in nearby groundwater testing. TasWater is currently developing alternative options to upgrade the existing system to increase the treatment process to tertiary level and mitigate any contamination risk in the future. Sorell Council's NRM and Environmental Health continue to monitor the condition and performance of the sewage lagoons.

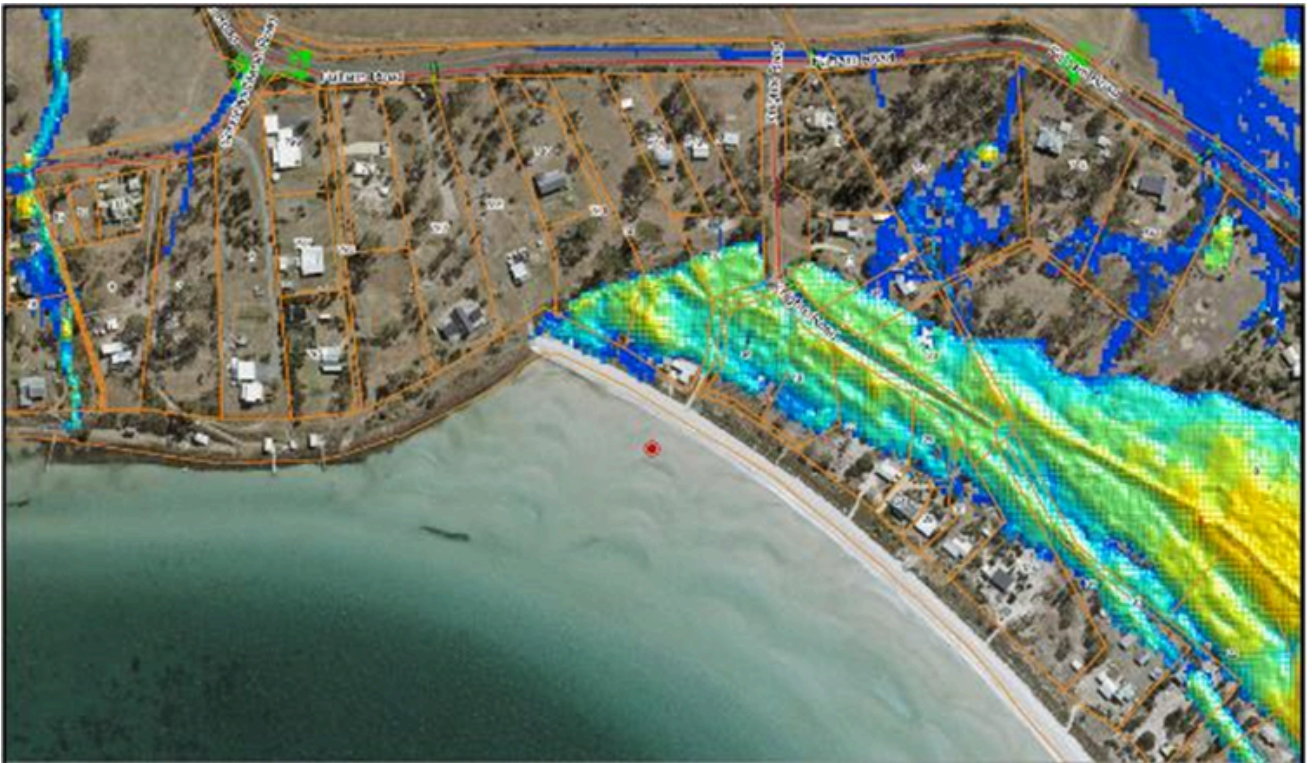
Figure 3 Connellys Marsh showing flood extent and stormwater infrastructure

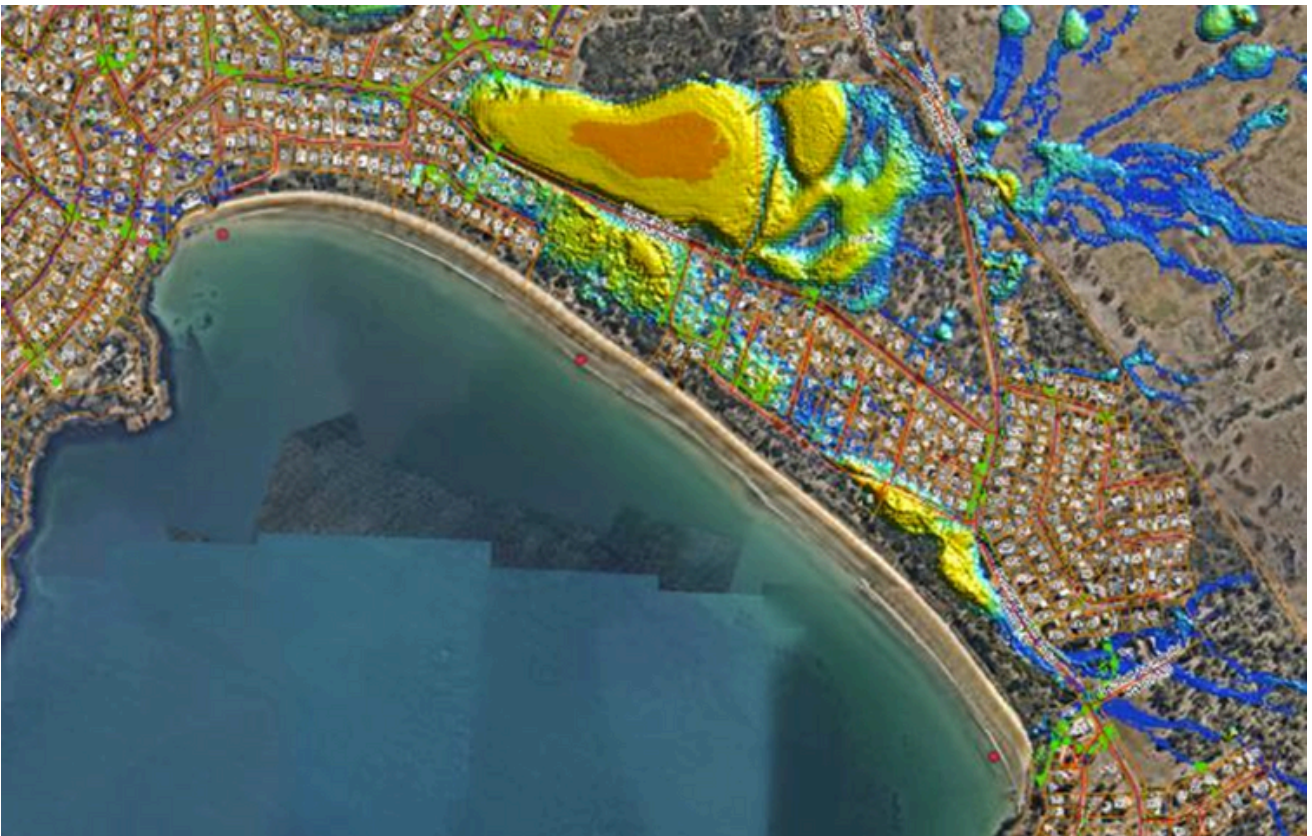
Figure 4 Primrose Sands Beach. Existing and two new sample points and showing flood extent and stormwater infrastructure

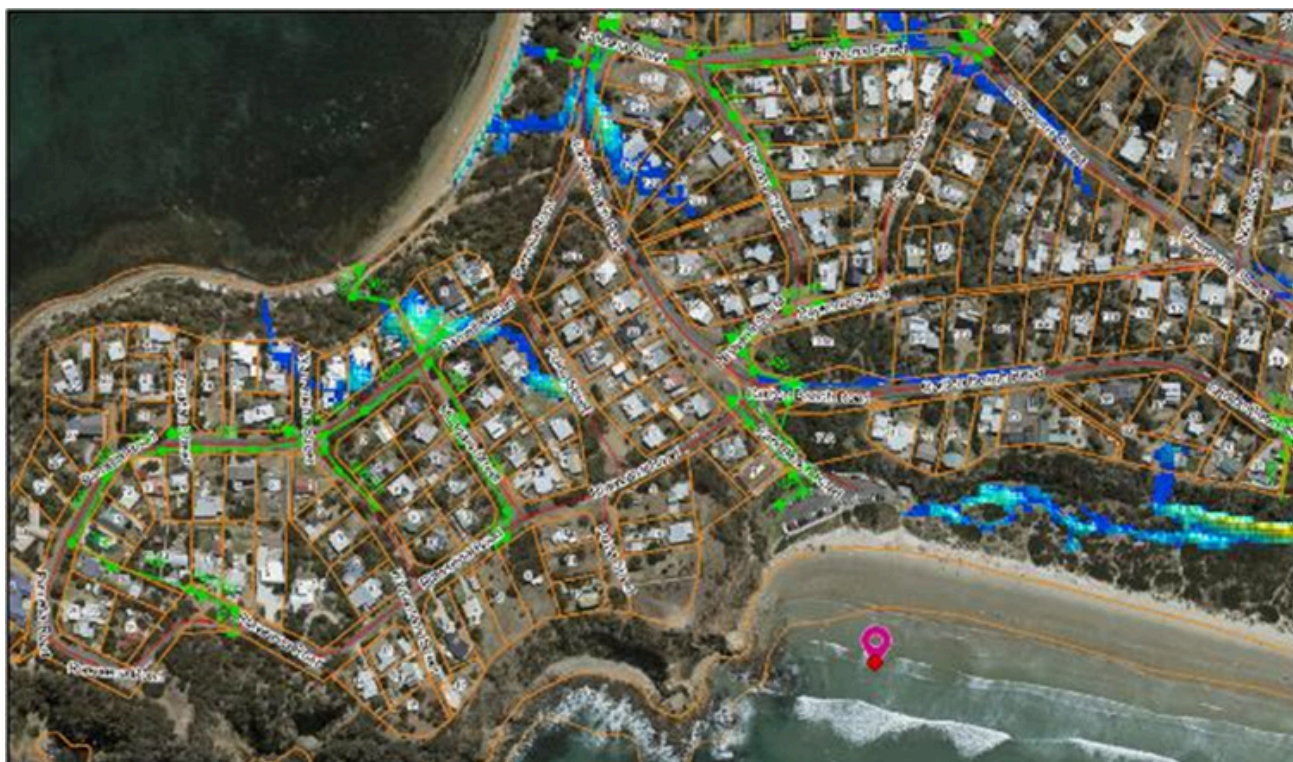
Figure 5 Park Beach Carlton showing flood extent and stormwater infrastructure

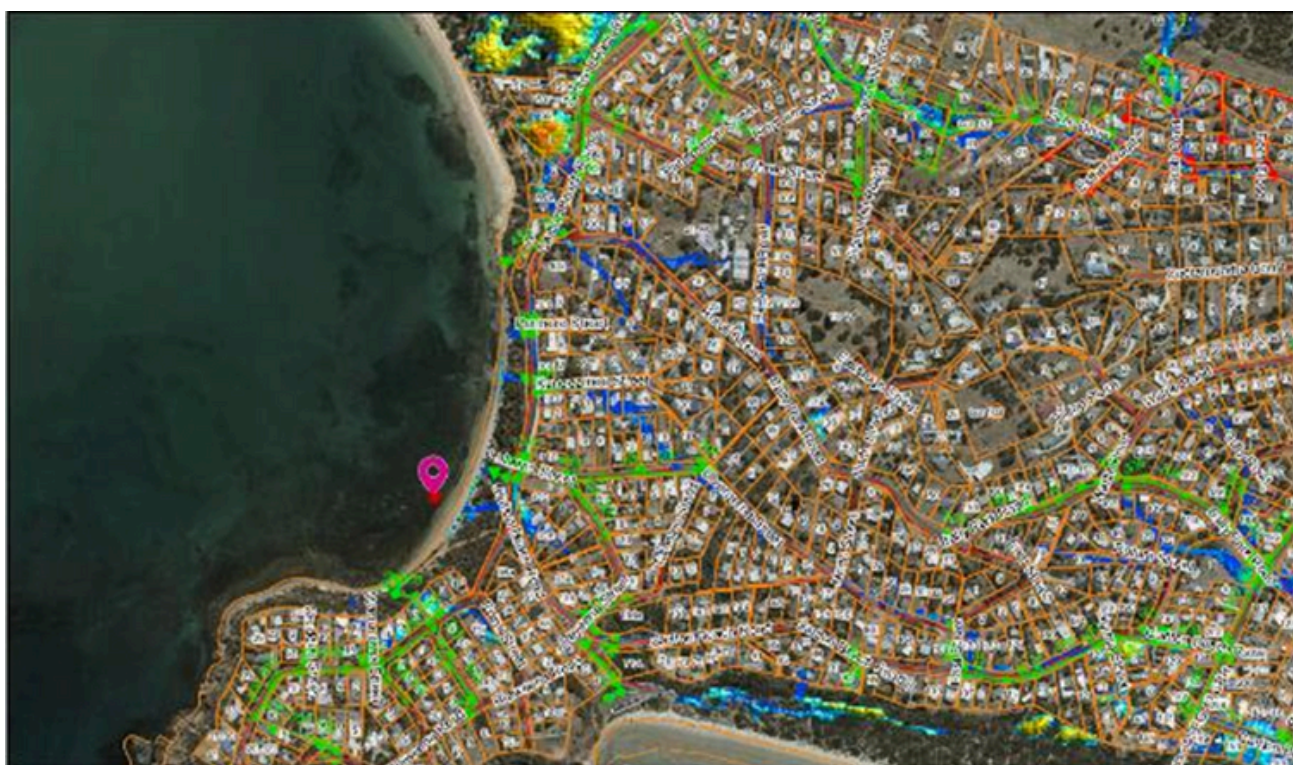
Figure 6 Red Ochre Beach South showing flood extent and stormwater infrastructure

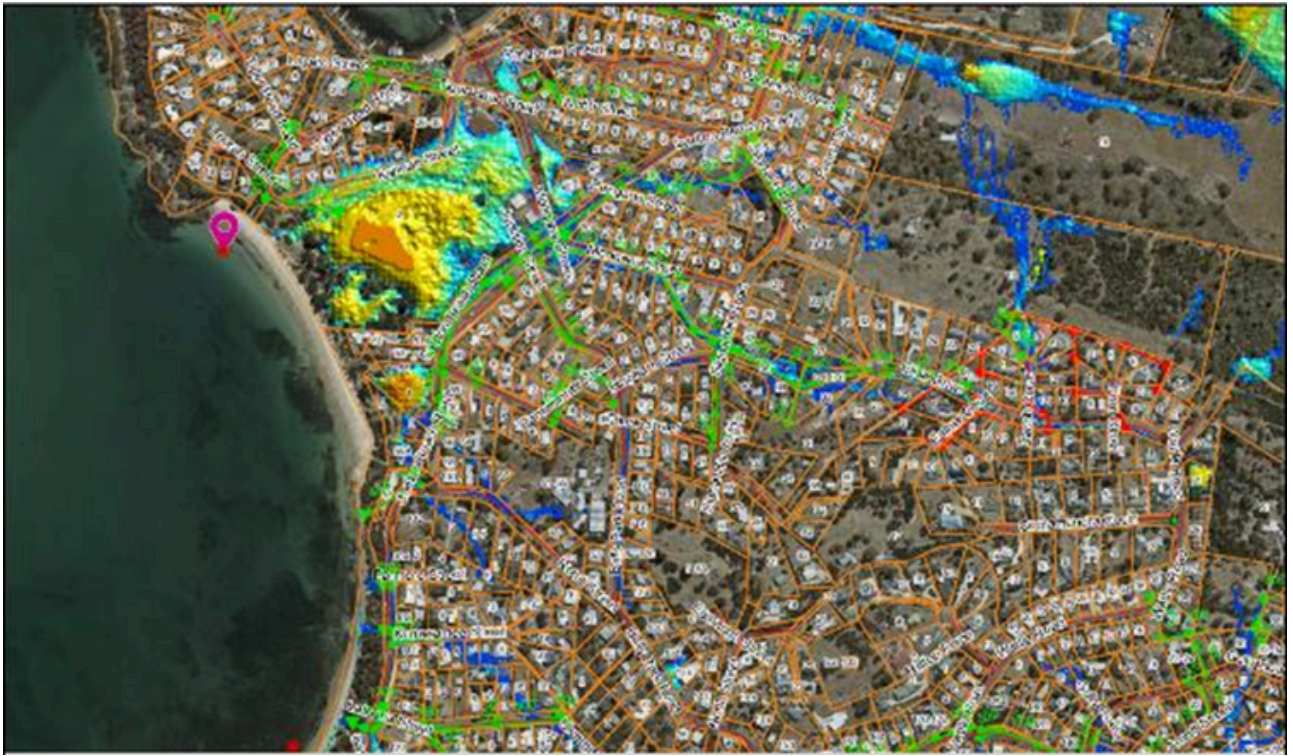
Figure 7 Red Ochre Beach North showing flood extent and stormwater infrastructure

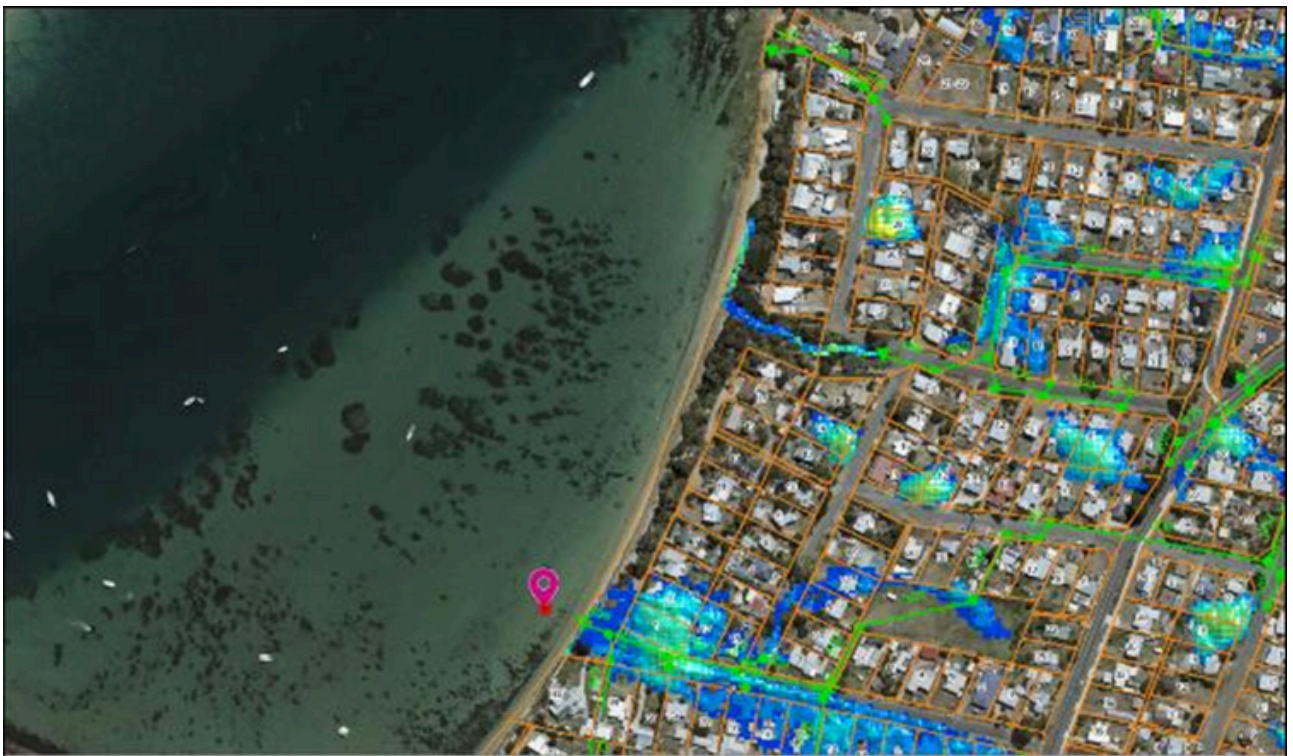
Figure 8 Tiger Head Beach @ 7th Ave showing flood extent and stormwater infrastructure

One of the major projects completed last year related to the Seventh Avenue stormwater upgrade. During construction contamination from historical cross connections from more than one dwelling was found and capped. The new pipework has increased the capacity for collecting stormwater within the catchment and the installation of a gross pollutant trap (GPT). With greater capacity to move stormwater, it reduces the flooding risk and therefore reduces failing OSWMS'. The GPT enables the capture of rubbish and other contaminants prior to entering the waterway. The results from the summer season showed Tigerhead had only one exceedance throughout the RWQ season. This occurred at the start of December. The high intensity rainfall event occurred after an extended period of dry weather. One may surmise that the first sample taken was highly influenced by a long period of dry weather with stagnant water pooling in the newly laid pipes for an extended period. This water was flushed out of the system. Once the first December rains abated, the results were compliant for the rest of the season.

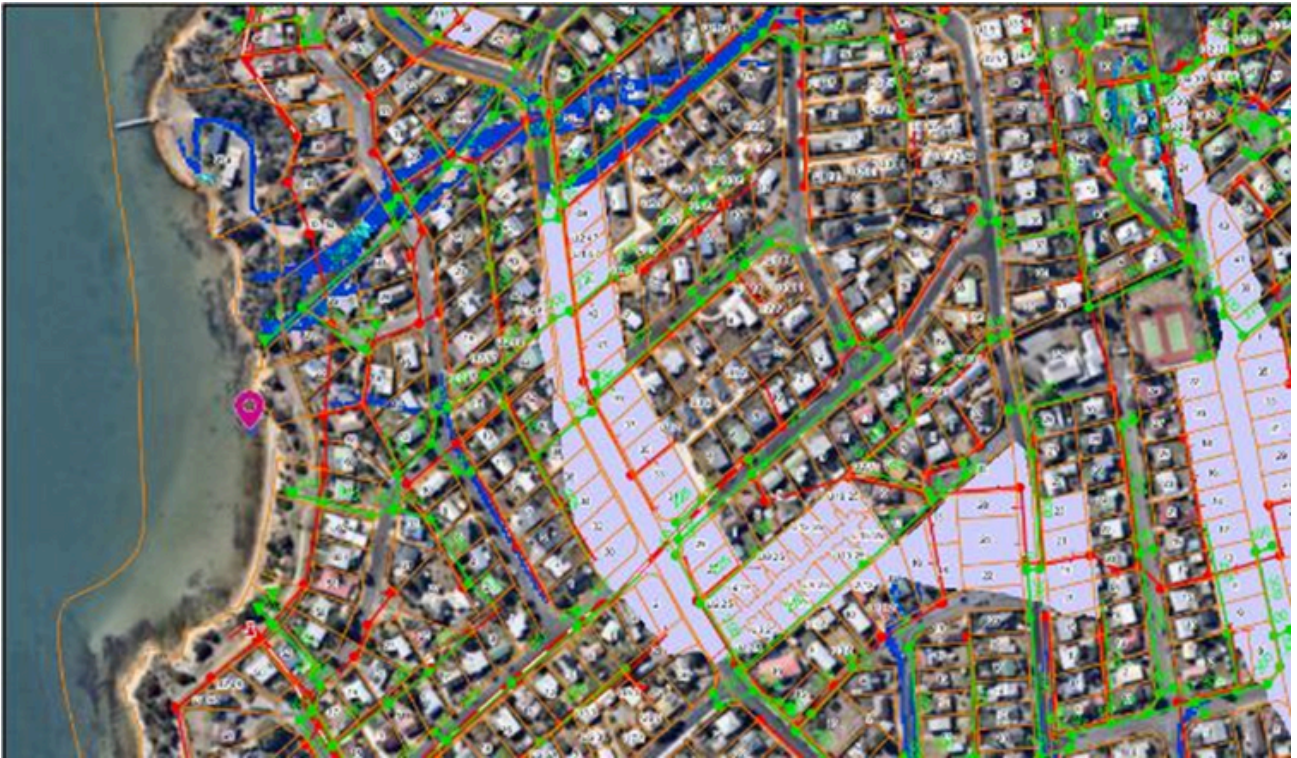
Figure 9 McKinly St Beach sewer in red; stormwater in green, flood risk and waterway shown
