NOTICE OF PROPOSED DEVELOPMENT

16 CLOVER COURT, CARLTON

DWELLING

PROPOSED DWELLING
16 CLOVER COURT,
CARLTON

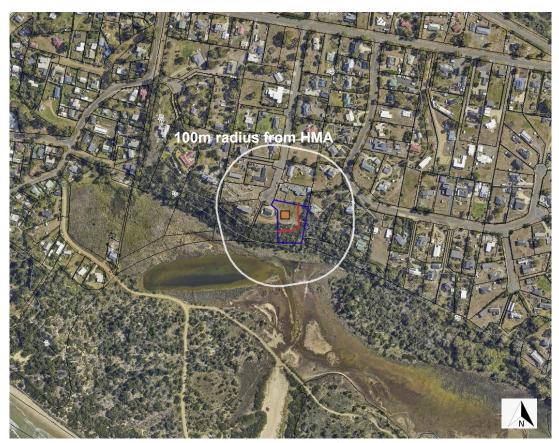
Figure 1: contoured listmap. www.thelist.tas.gov.au. Subject dwelling in orange and black. 100m radius is from proposed HMA (red line).

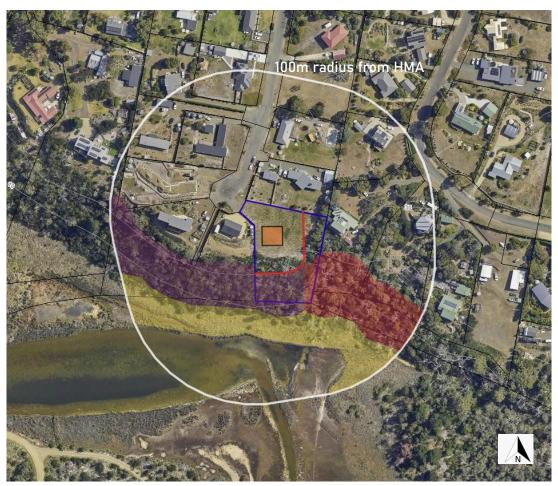
Figure 3: contoured aerial listmap. www.thelist.tas.gov.au. Proposed dwelling in orange and black. Red shading shows forest bushfire prone vegetation within 100m of the proposal, yellow shading grassland bushfire prone vegetation and purple scrub. Red line is proposed HMA.

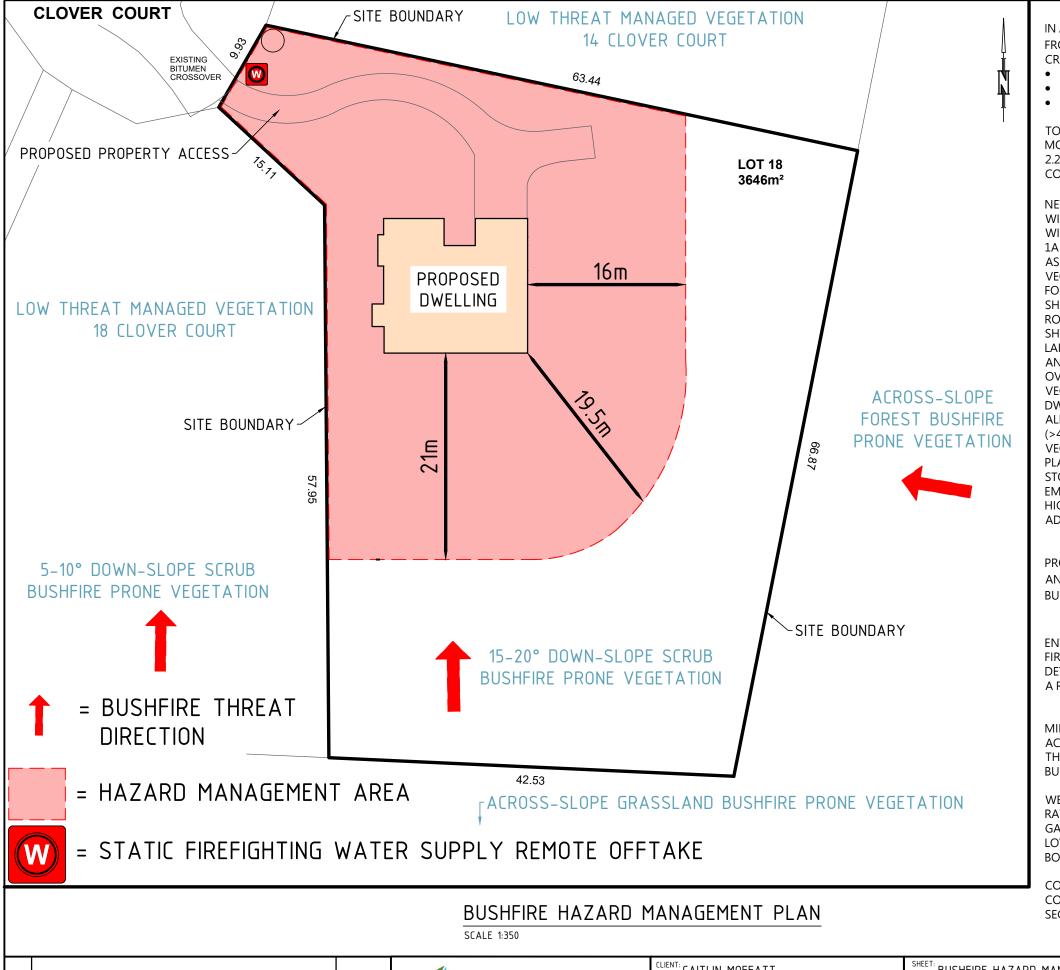
Appendix C - Bushfire Hazard Management Plan

VEGETATION:

IN ACCORDANCE WITH TABLE 2.6 IN AS3959, 2018.

FROM THE PROPOSED DWELLING, SEPARATION DISTANCES ARE REQUIRED TO CREATE A HAZARD MANAGEMENT AREA (HMA) WITH DIMENSIONS OF:

- In accordance with Table 2.6 in AS3959 2018:
 - A hazard management area (HMA) is required with separation distances of:
 - To the property boundary on the western and northern aspects;
 - A minimum 16m on the eastern aspect;
 - o A minimum 21m on the southern aspect.

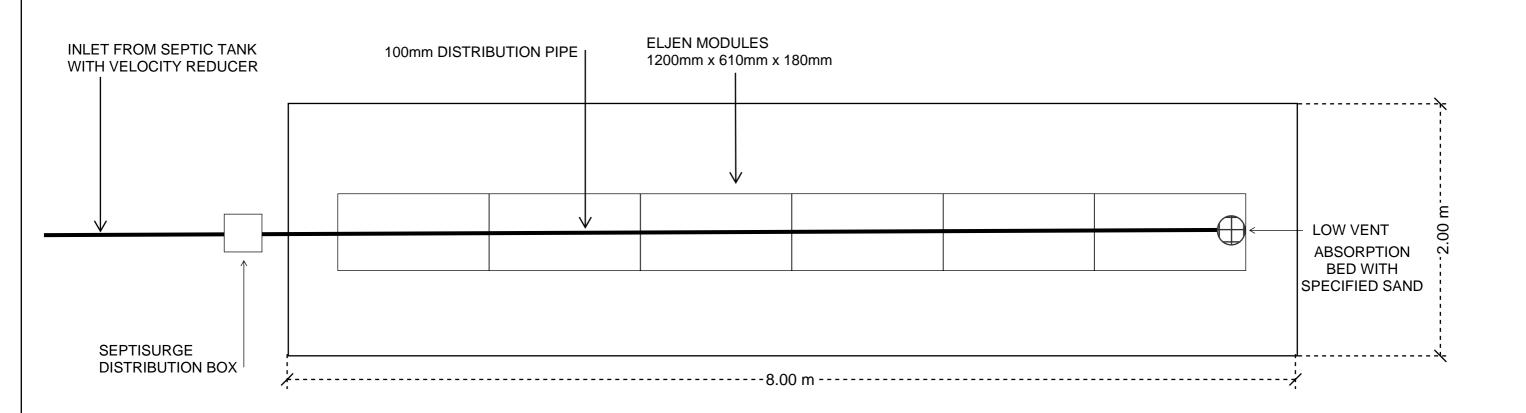
Eljen Bed Plan - 16m²

1 row of 6 units

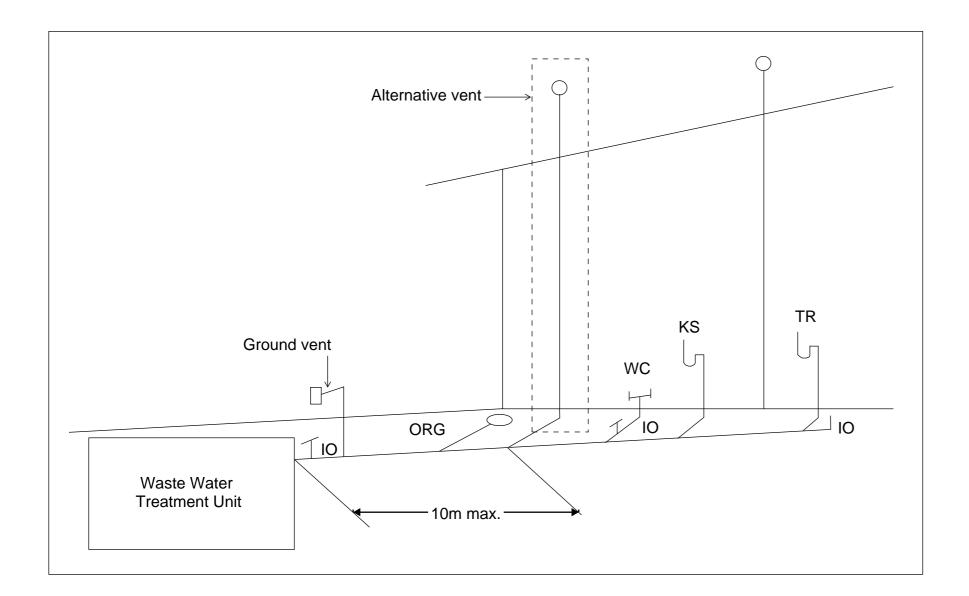
Tas Figure C2D6 Alternative Venting Arrangements

Vents must terminate in accordance with AS/NZS 3500.2

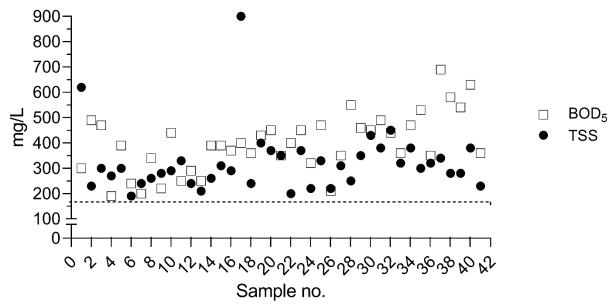
Figure 3. Overview of BOD₅ and TSS for the influent wastewater during the 34-week testing period (horizontal dashed line shows ≤150 mg/L lower limit for BOD₅ and TSS as per AS 1546.3:2017 Table A1).

The concentrations of BOD_5 and TSS in the influent wastewater during the 34-week testing period (41 samples) are plotted in Figure 3 below. NB. There was one instance where raw sewage TSS exceeded the recommended upper maximum threshold value of AS 1546.3:2017 Table A1 (i.e. 750 mg/L); however, there were no adverse effects on treated effluent quality observed as a result of the high TSS load and so this data was retained.

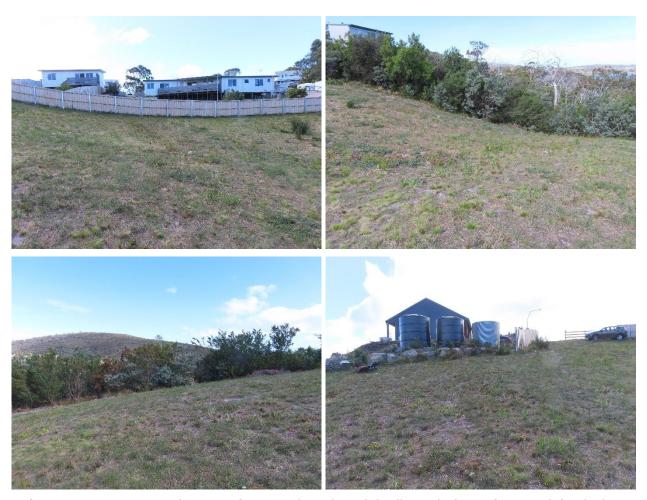
Plates 1-4. Approximate location of proposed residential dwelling: clockwise from top left – looking north, east, south and west

residentially-occupied titles to the north and west; with a fringe of unfenced and long-undisturbed native scrub along the eastern boundary and on the steeper south-facing slopes (Plates 2 & 3 plus Plates 5 & 6)

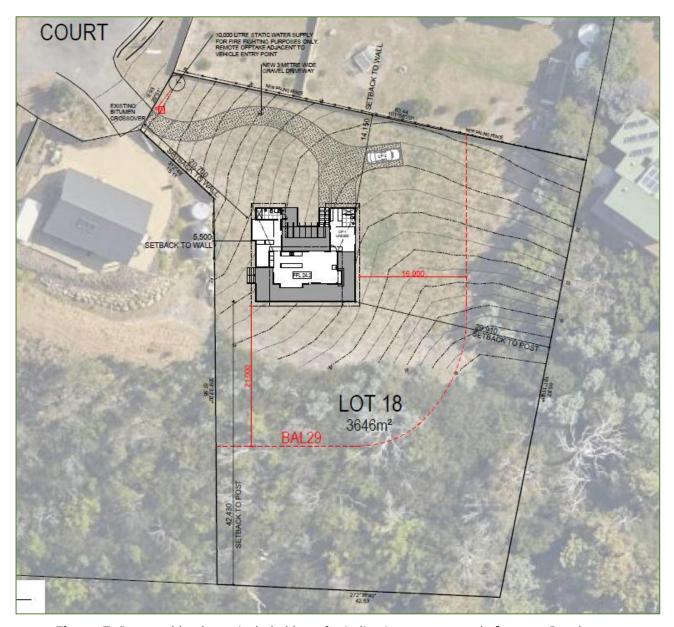
Figure 7. Proposed land use, included here for indicative purposes only [source: Beachouse Architecture]

The proposal is for a single residential dwelling with a BAL-29 hazard management area (Figure 7).

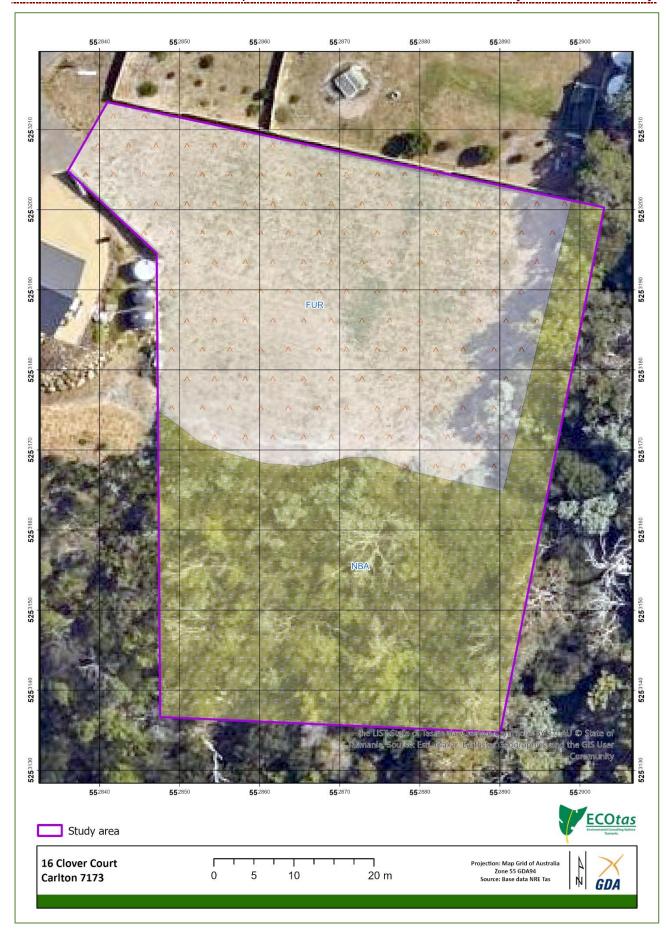
Figure 12a. Revised vegetation mapping for subject title (refer to text for codes)

Site assessment indicated that the cleared parts of the title are best classified as FUR (Figure 12). While this area includes several native plant species, it is long-managed as cleared land and is in the context of a largely fenced small suburban setting (see Plates 1-4). The long-undisturbed scrub fringing the area of FUR (see Plates 5 & 6) is best attributed to *Bursaria – Acacia* woodland and scrub (TASVEG code: NBA) as it is dominated by a dense closed canopy of *Bursaria spinosa, Dodonaea viscosa, Banksia marginata* and *Acacia dealbata*. This scrub has affinities to coastal scrub (TASVEG code: SSC) due to the sandy substrate and ground layer species (e.g. *Lepidosperma concavum, Pteridium esculentum, Lomandra longifolia*) but whether it is coded as SSC or NBA is of no consequence in terms of its conservation priority.

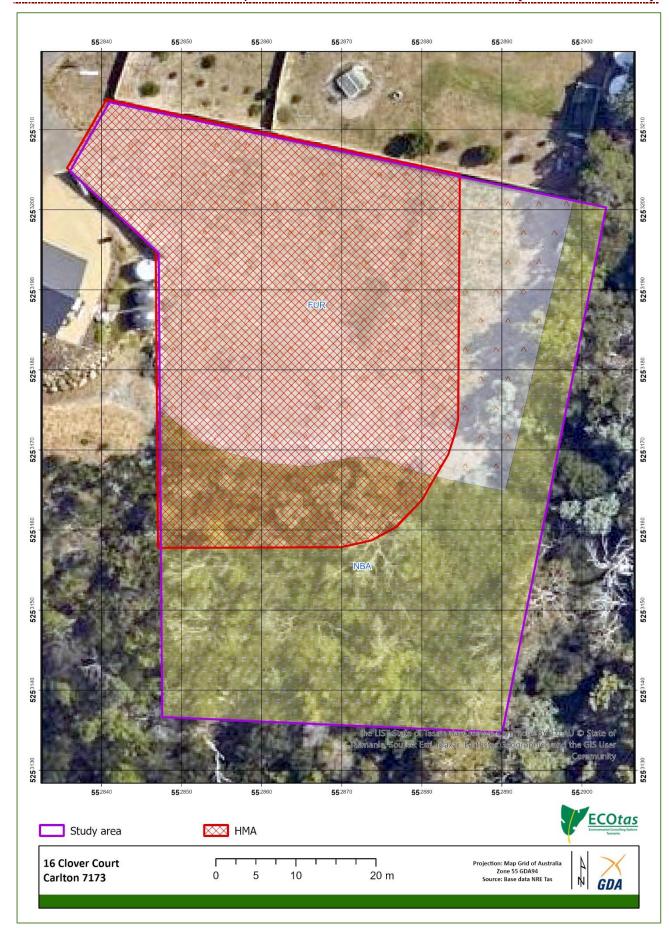
Figure 12b. Revised vegetation mapping for subject title (refer to text for codes) showing proposed hazard management area

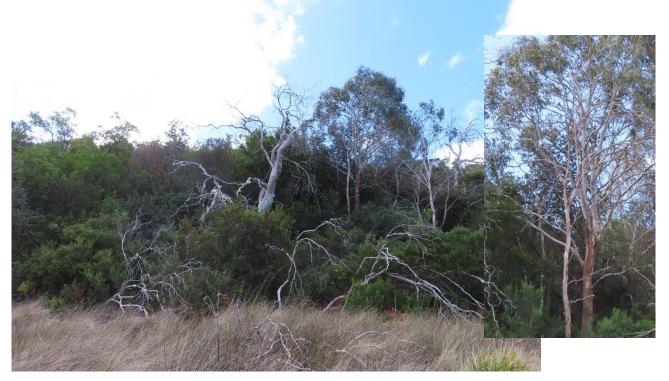
Plate 7. Looking north into title (left of centre) showing extensive dieback of *Eucalyptus viminalis* – the one live tree (just off-title) has symptoms of "ginger tree syndrome" – inset)

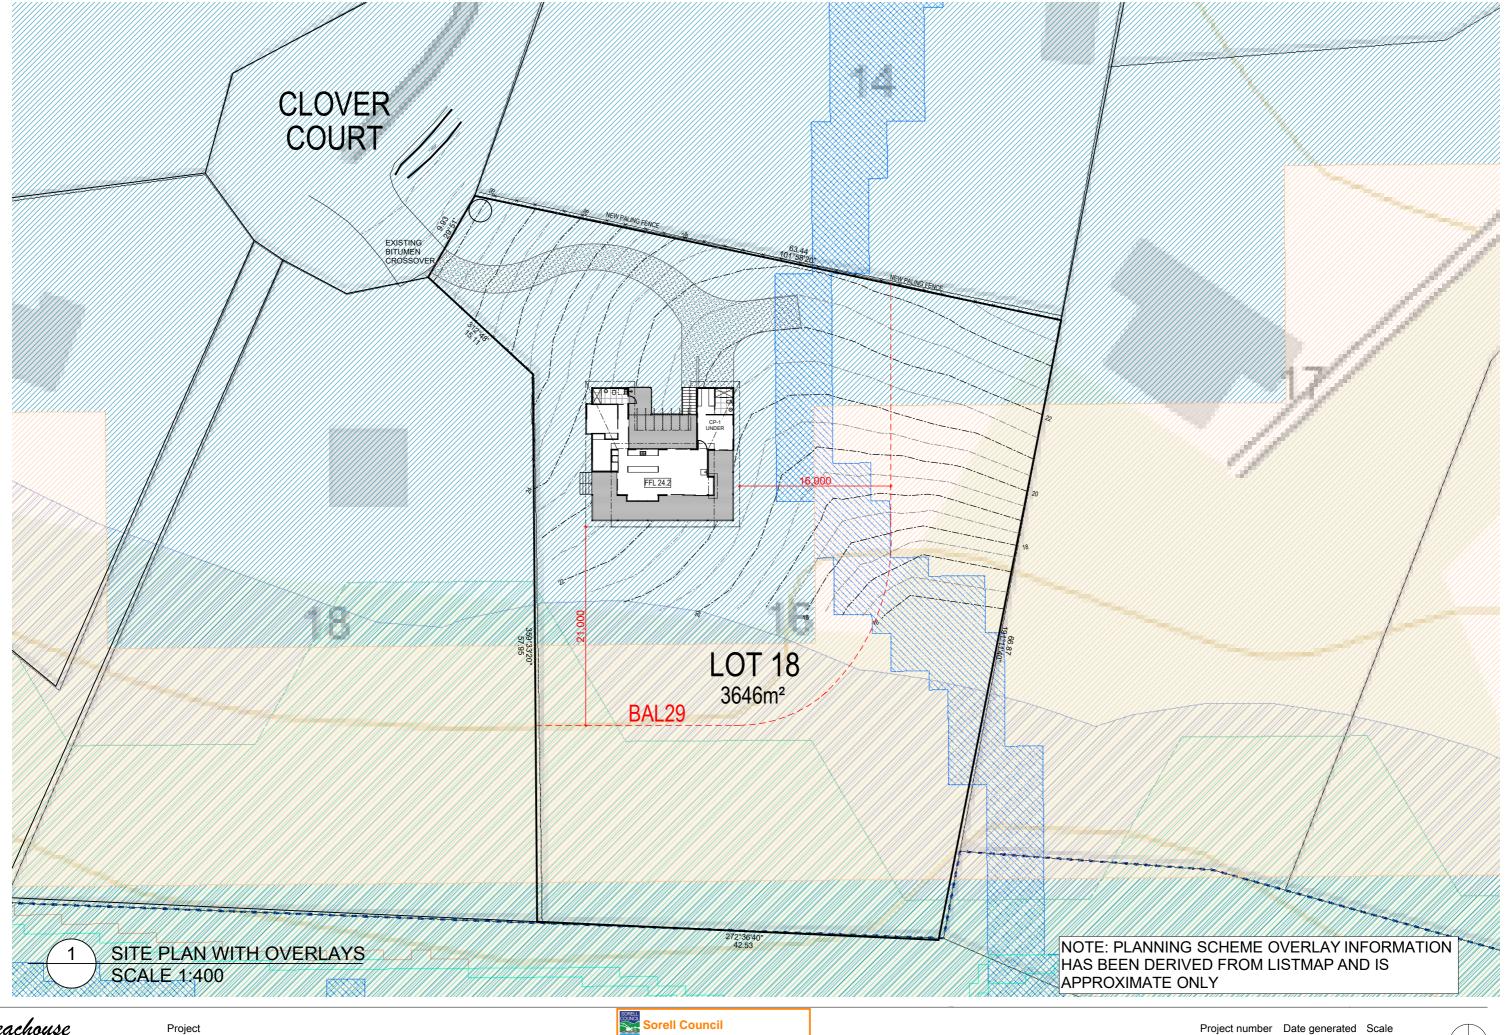
Drawing number Revision 01.02

NEW DWELLING - 16 CLOVER COURT, CARLTON, FOR CAITLIN MOFFATT 11 RIVER STREET, CARLTON, TASMANIA. PH: 03 6265 8295 info@beachouse.net.au www.beachouse.net.au DEVELOPMENT APPLICATION - SITE PLAN WITH OVERLAYS

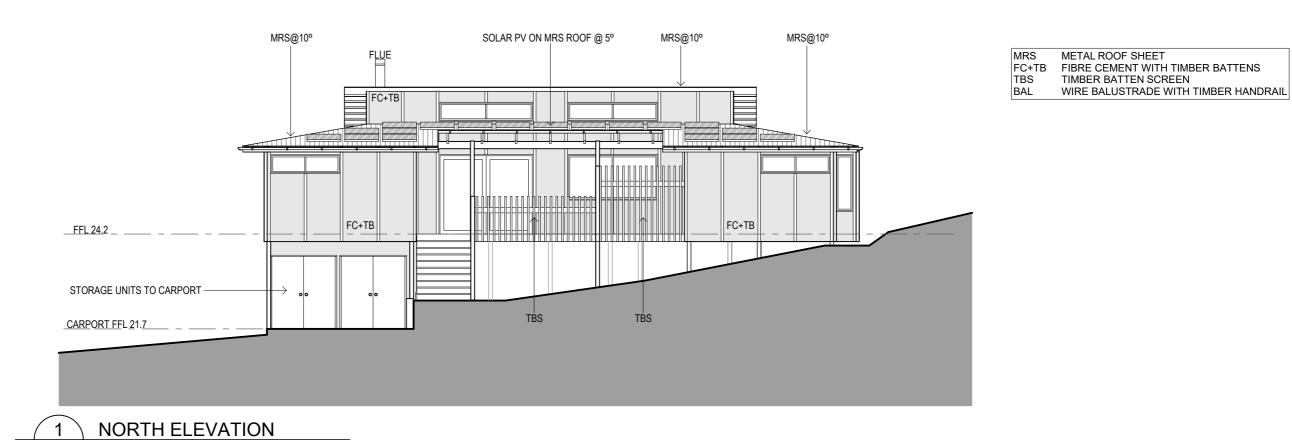
FLUE MRS@10° MRS@10° SOLAR PV ON MRS ROOF @ 5° 6,600 MAX. HEIGHT ABOVE NATURAL GROUND FC+TB FC+TB FFL 24.2 СВ WATER STORAGE TANKS
