Sorell Council Southern Beaches CERMP Outfall Project

Outfall Project 5_SE112501

First Avenue Anna Wilson December 2023

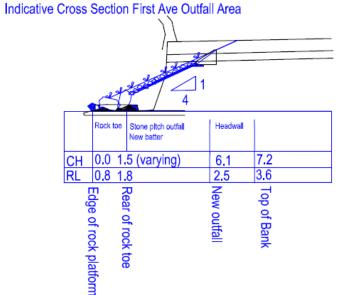
Ex surface - batter to grade.

Overlap and bottom end to be pinned at 300mm centres.

Pins - Mild Steel - min length 300mm.

Remove 2 casurinas on edge of embankment
Remove pipe end to match new grade
Install 375dia endwall as per TSD SW-17
