NOTICE OF PROPOSED DEVELOPMENT

SITE: Lot 501 Primrose Sands Road, Primrose Sands

**PROPOSED DEVELOPMENT:
FOOD SERVICES - CAFE**

APPLICANT: Pinnacle Drafting and Design

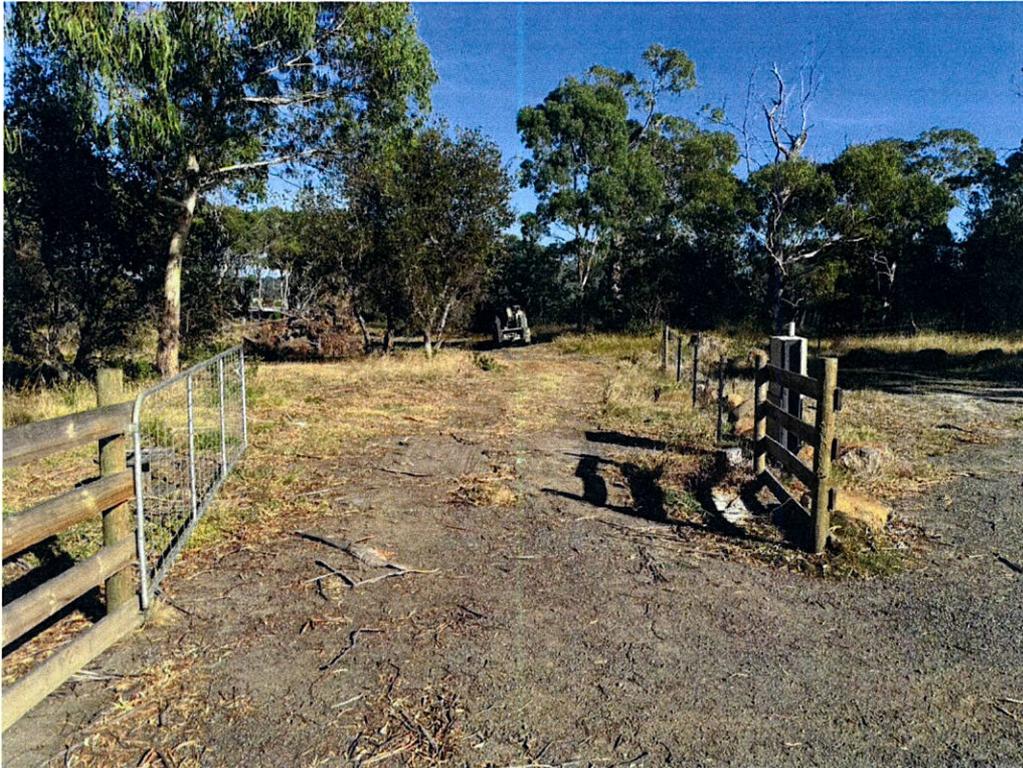
Plate 1 – Looking to the west from Primrose Sands Road at the proposed café site.

It is proposed to construct a small café and neighbouring shed on the 115400m² vacant block at 432 Primrose Sands Road. The café will be accessed directly from Primrose Sands Road (Figure 1, Plate 1). The site is underlain by deep sand.

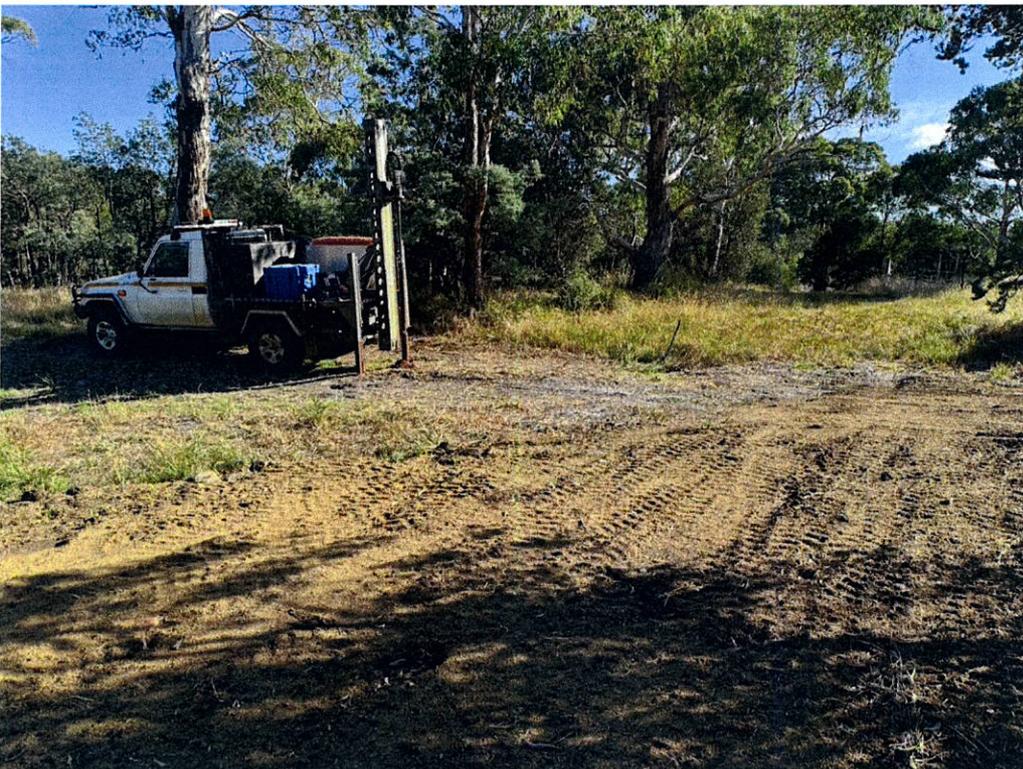
Plate 2 – Café site - Looking to the north (Test Hole #1).

The profiles encountered in the Test Holes (Plate 2) consisted of:

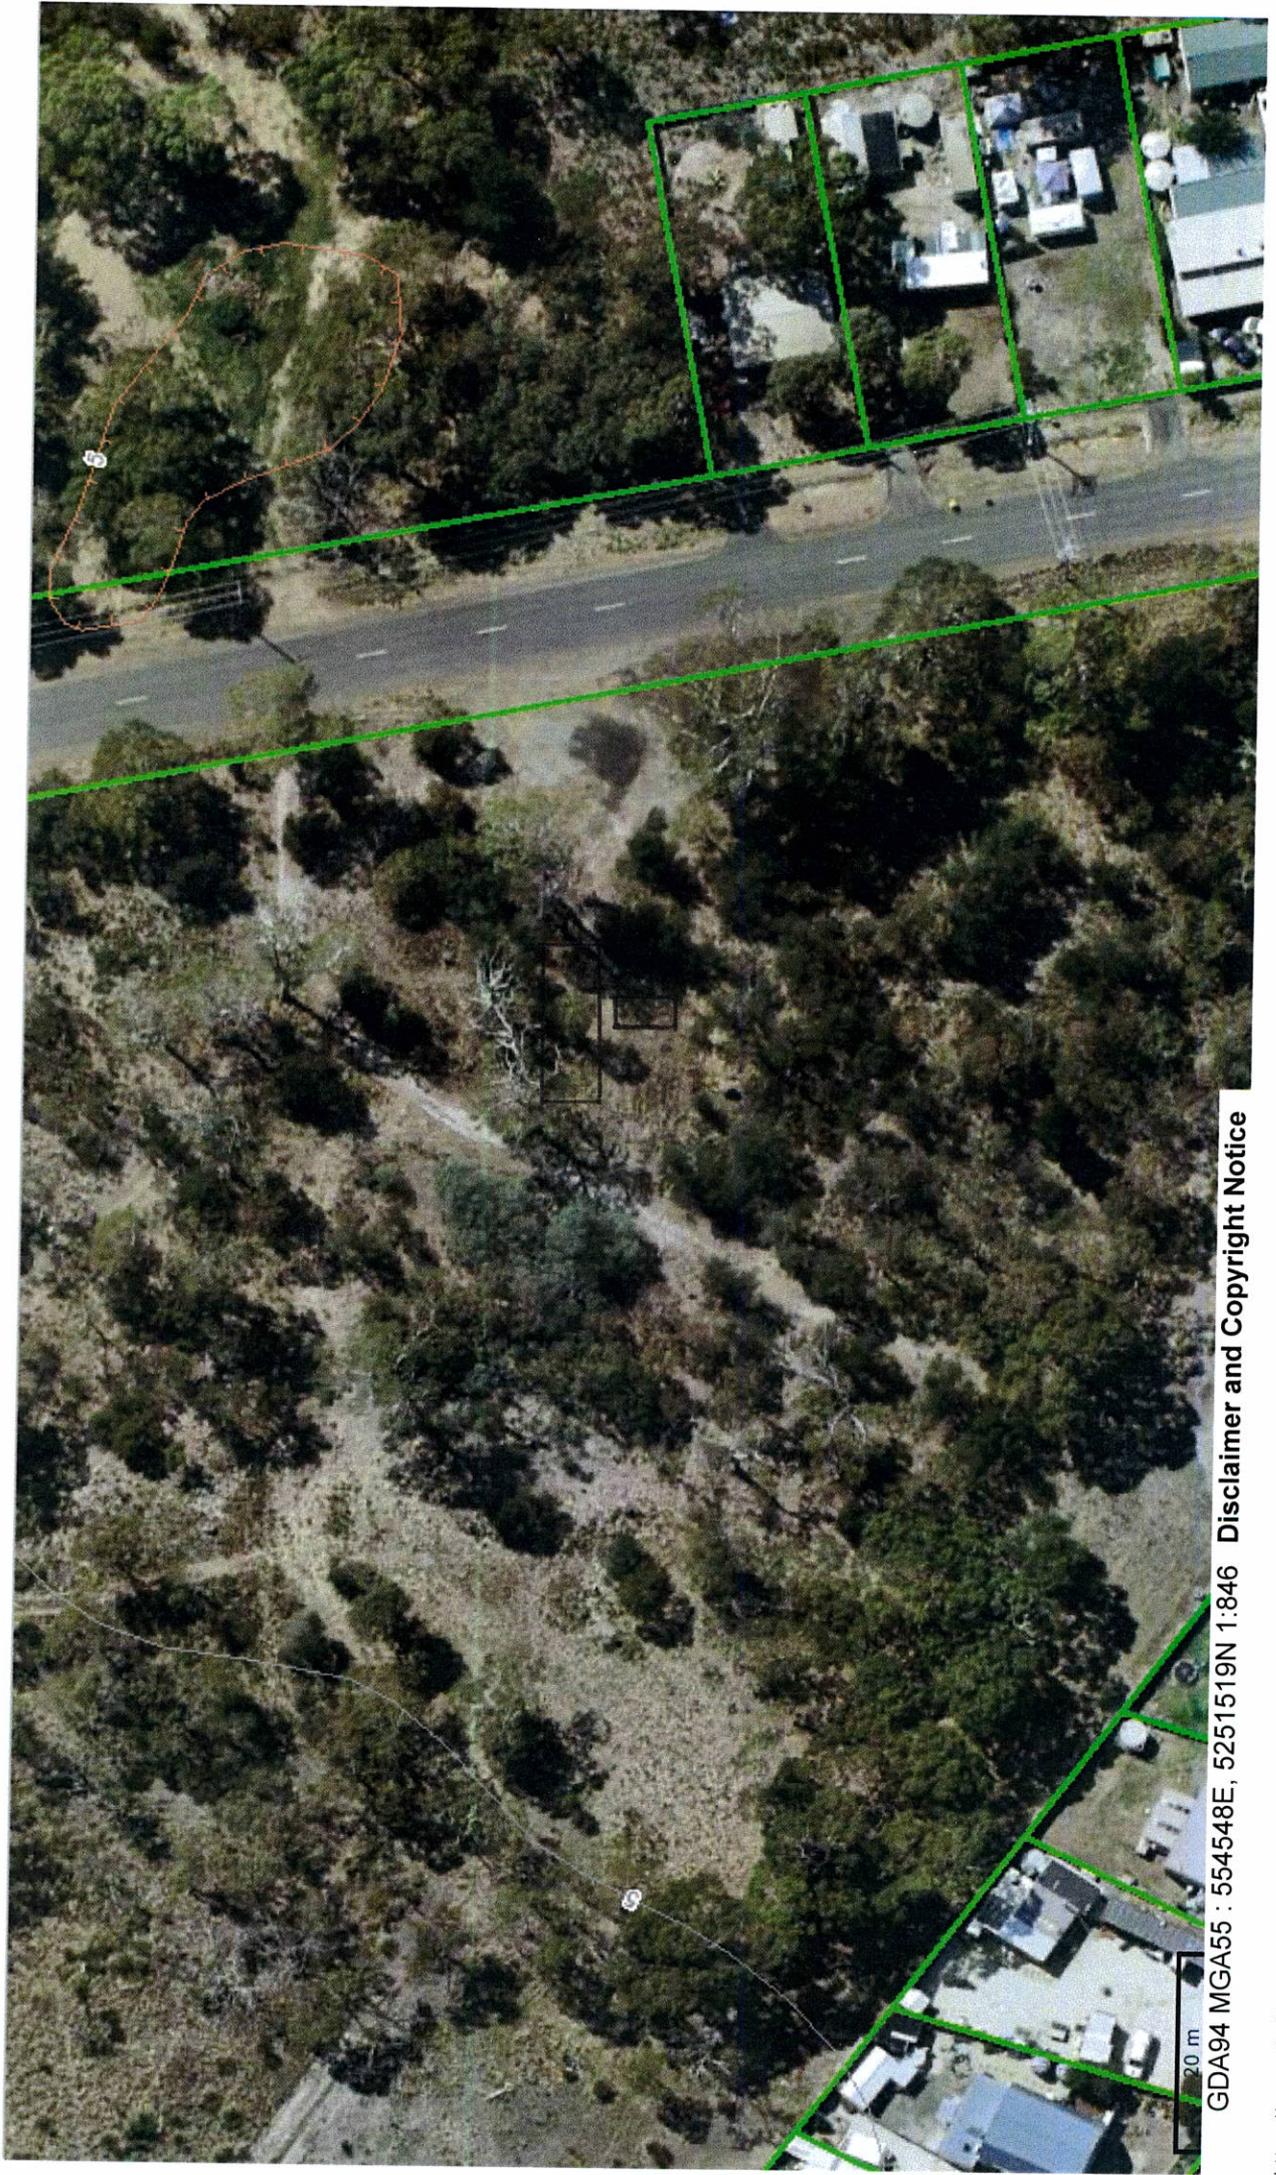
LOCALITY MAP
SAFE + SHED

A site investigation was completed on Friday 28 March, 2025. This included the augering of four test holes to assess the site for foundation, onsite wastewater, and stormwater conditions (4WD mounted SAMPLA25 mechanical auger with 100mm diameter solid flight augers). The locations of the auger holes are marked on Figure 1.

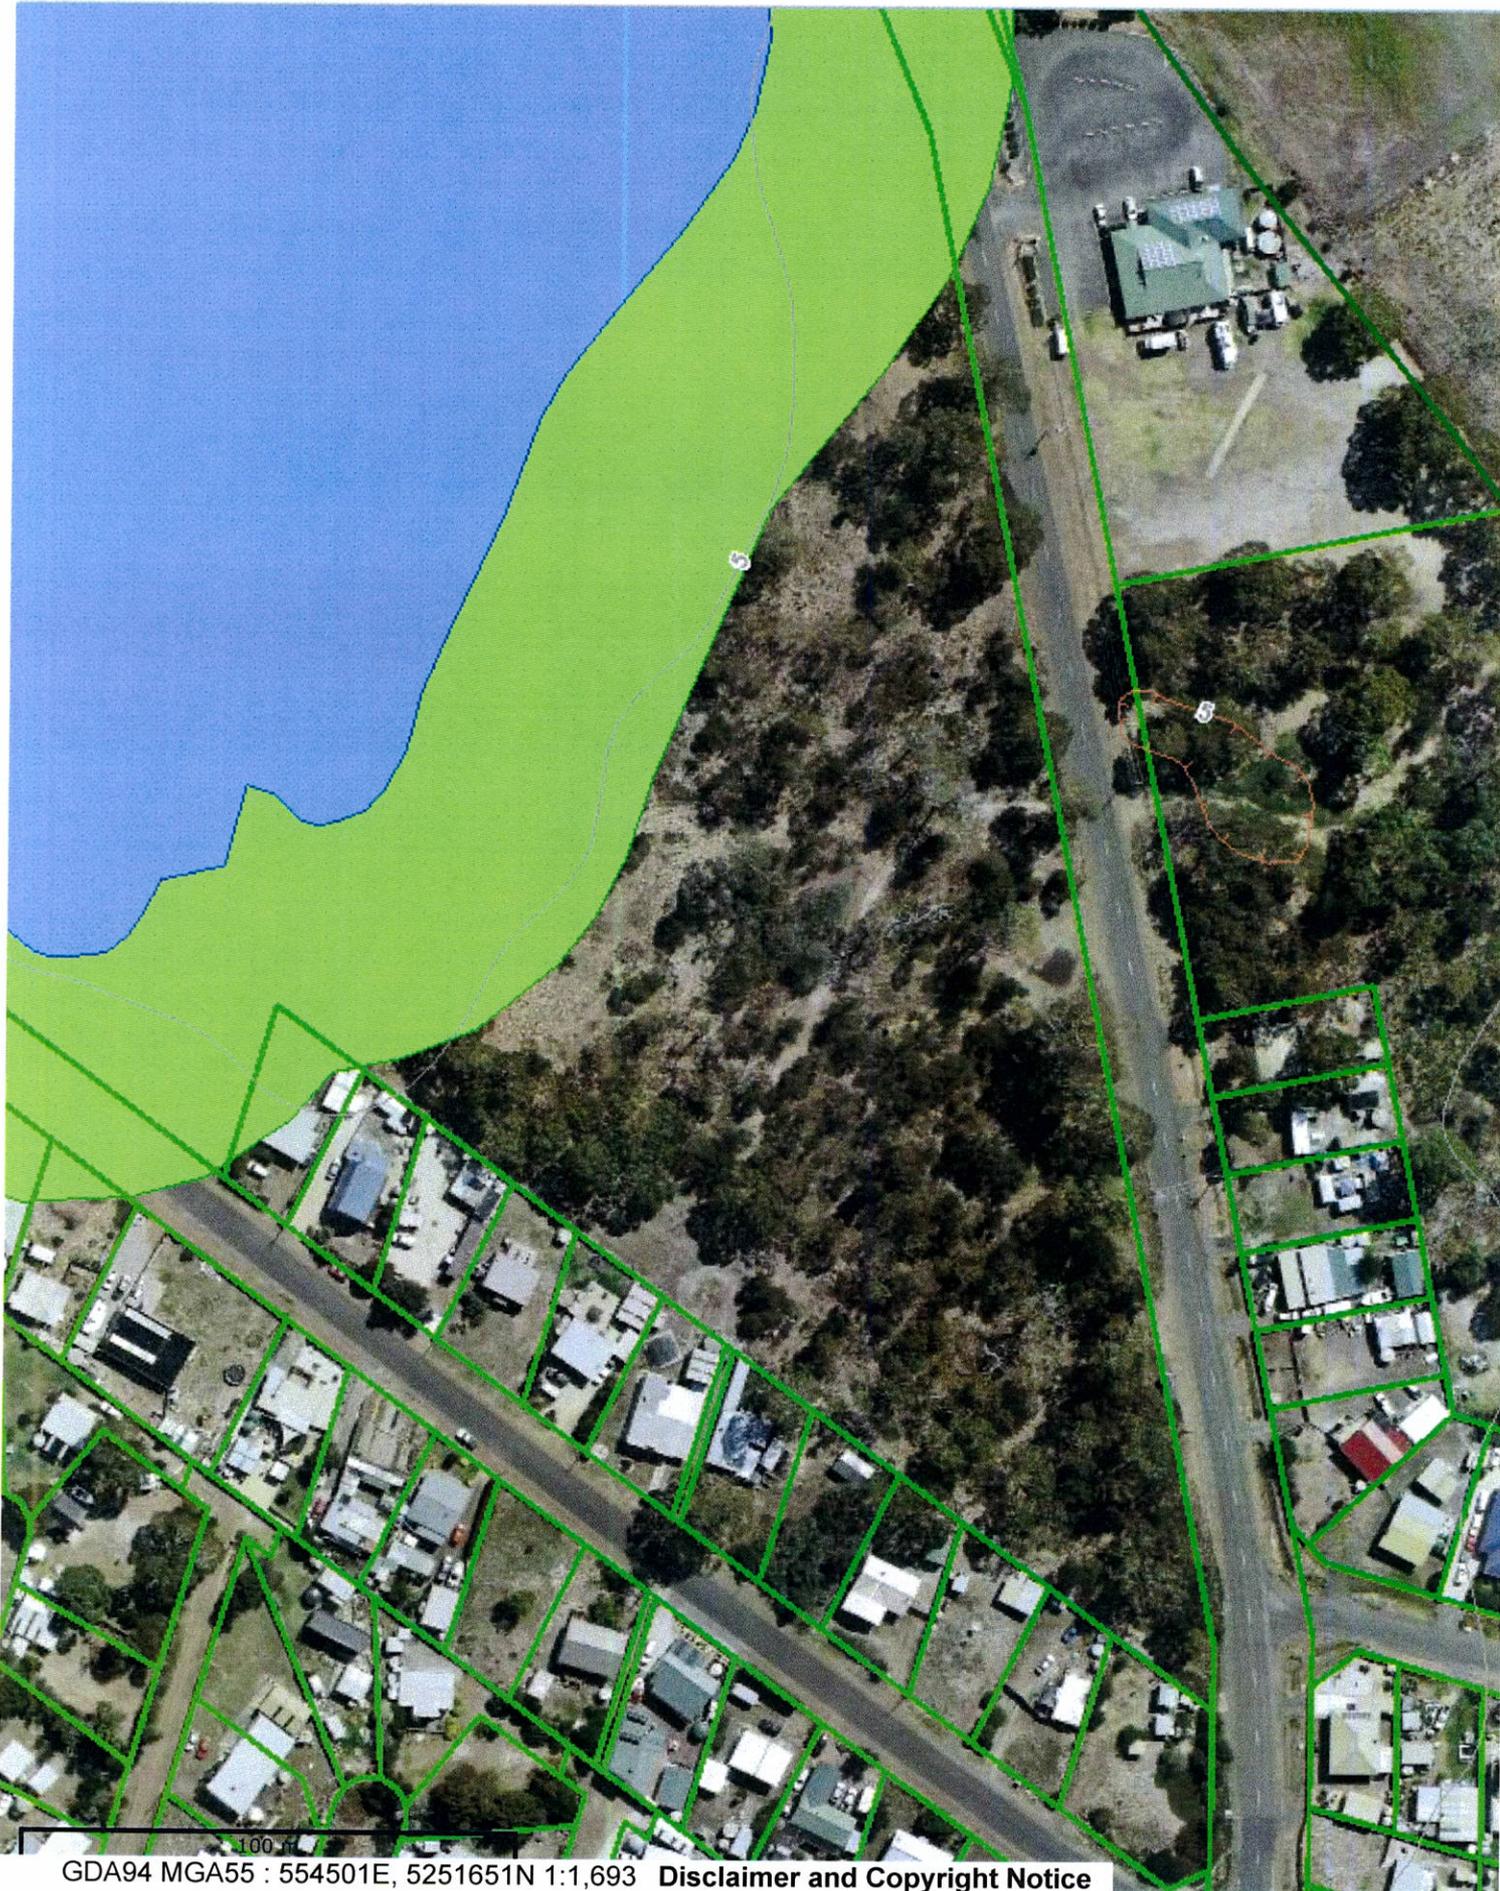
WATERWAY + COASTAL PROTECTION ZONE

- f) Any watercourses on the land; **See Figure 2. Development site a minimum of 50m from the defined Waterway and Coastal Protection Area.**
- g) Stormwater quality and quantity management targets identified in the *State Stormwater Strategy 2010*, and **Stormwater consist of rainwater collected from the roofs of the café and shed.**

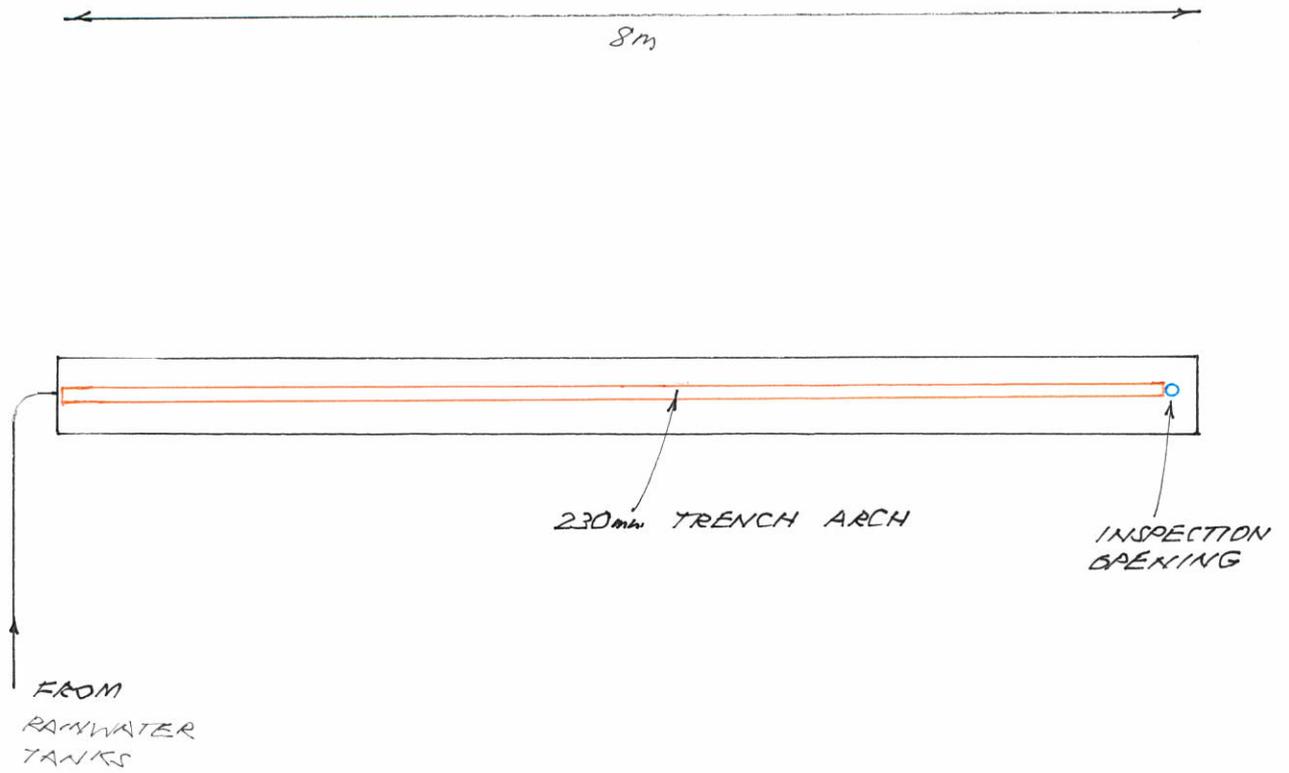
CROSS-SECTION TRENCHES

The trench will consist of 230mm trench arch in drain gravel (Figure 3).

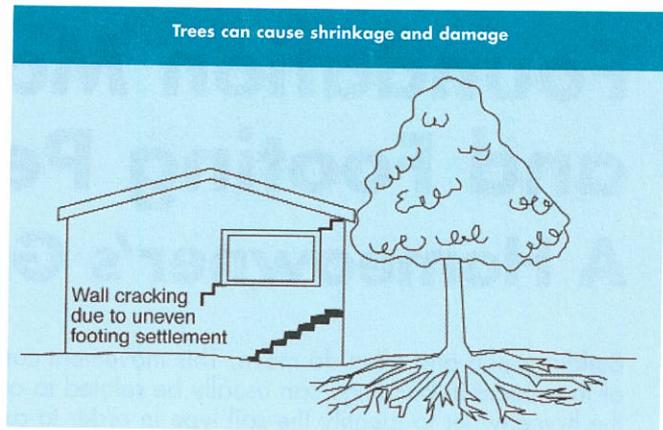
As the moisture absorption process completes its journey to the innermost areas of the building, the internal footings will rise. If the spread of moisture is roughly even, it may be that the symptoms will temporarily disappear, but it is more likely that swelling will be uneven, creating a difference rather than a disappearance in symptoms. In buildings with timber flooring supported by bearers and joists, the isolated piers will rise more easily than the strip footings or piers under walls, creating noticeable doming of flooring.

As the weather pattern changes and the soil begins to dry out, the external footings will be first affected, beginning with the locations where the sun's effect is strongest. This has the effect of lowering the external footings. The doming is accentuated and cracking reduces or disappears where it occurred because of dishing, but other cracks open up. The roof lines may become convex.

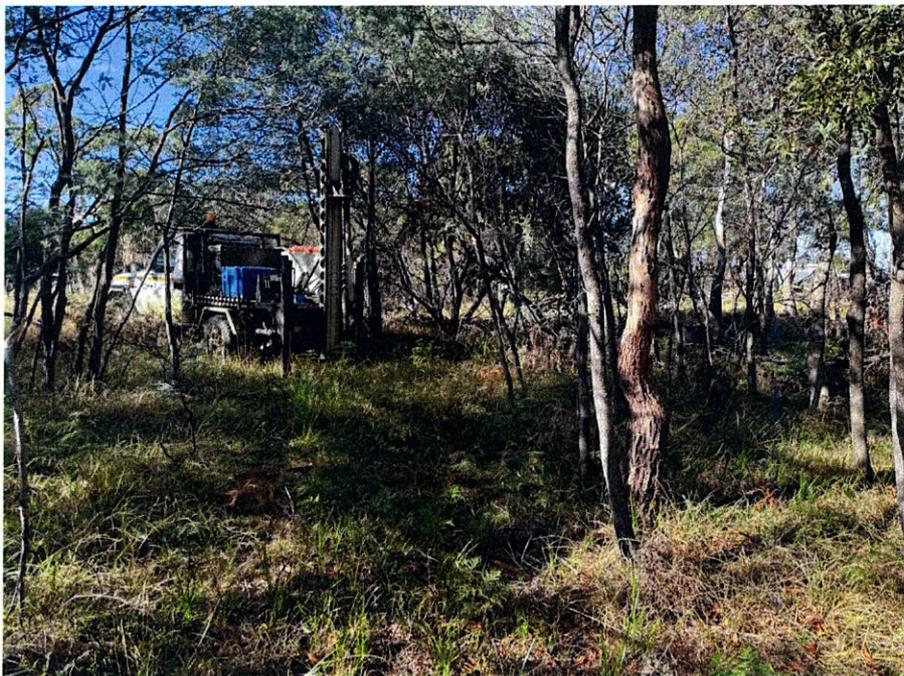
Plate 3 – Test Hole #3 – looking to the east.

Vacant land immediately to the west of the proposed café and shed was assessed for onsite wastewater and stormwater suitability. This area is undulating in profile, but generally slopes shallowly to the west at 1-2 degrees. The site is covered in native grasses, shrubs, and semi-mature trees. The profiles encountered in the Test Holes (Plate 3) consisted of:

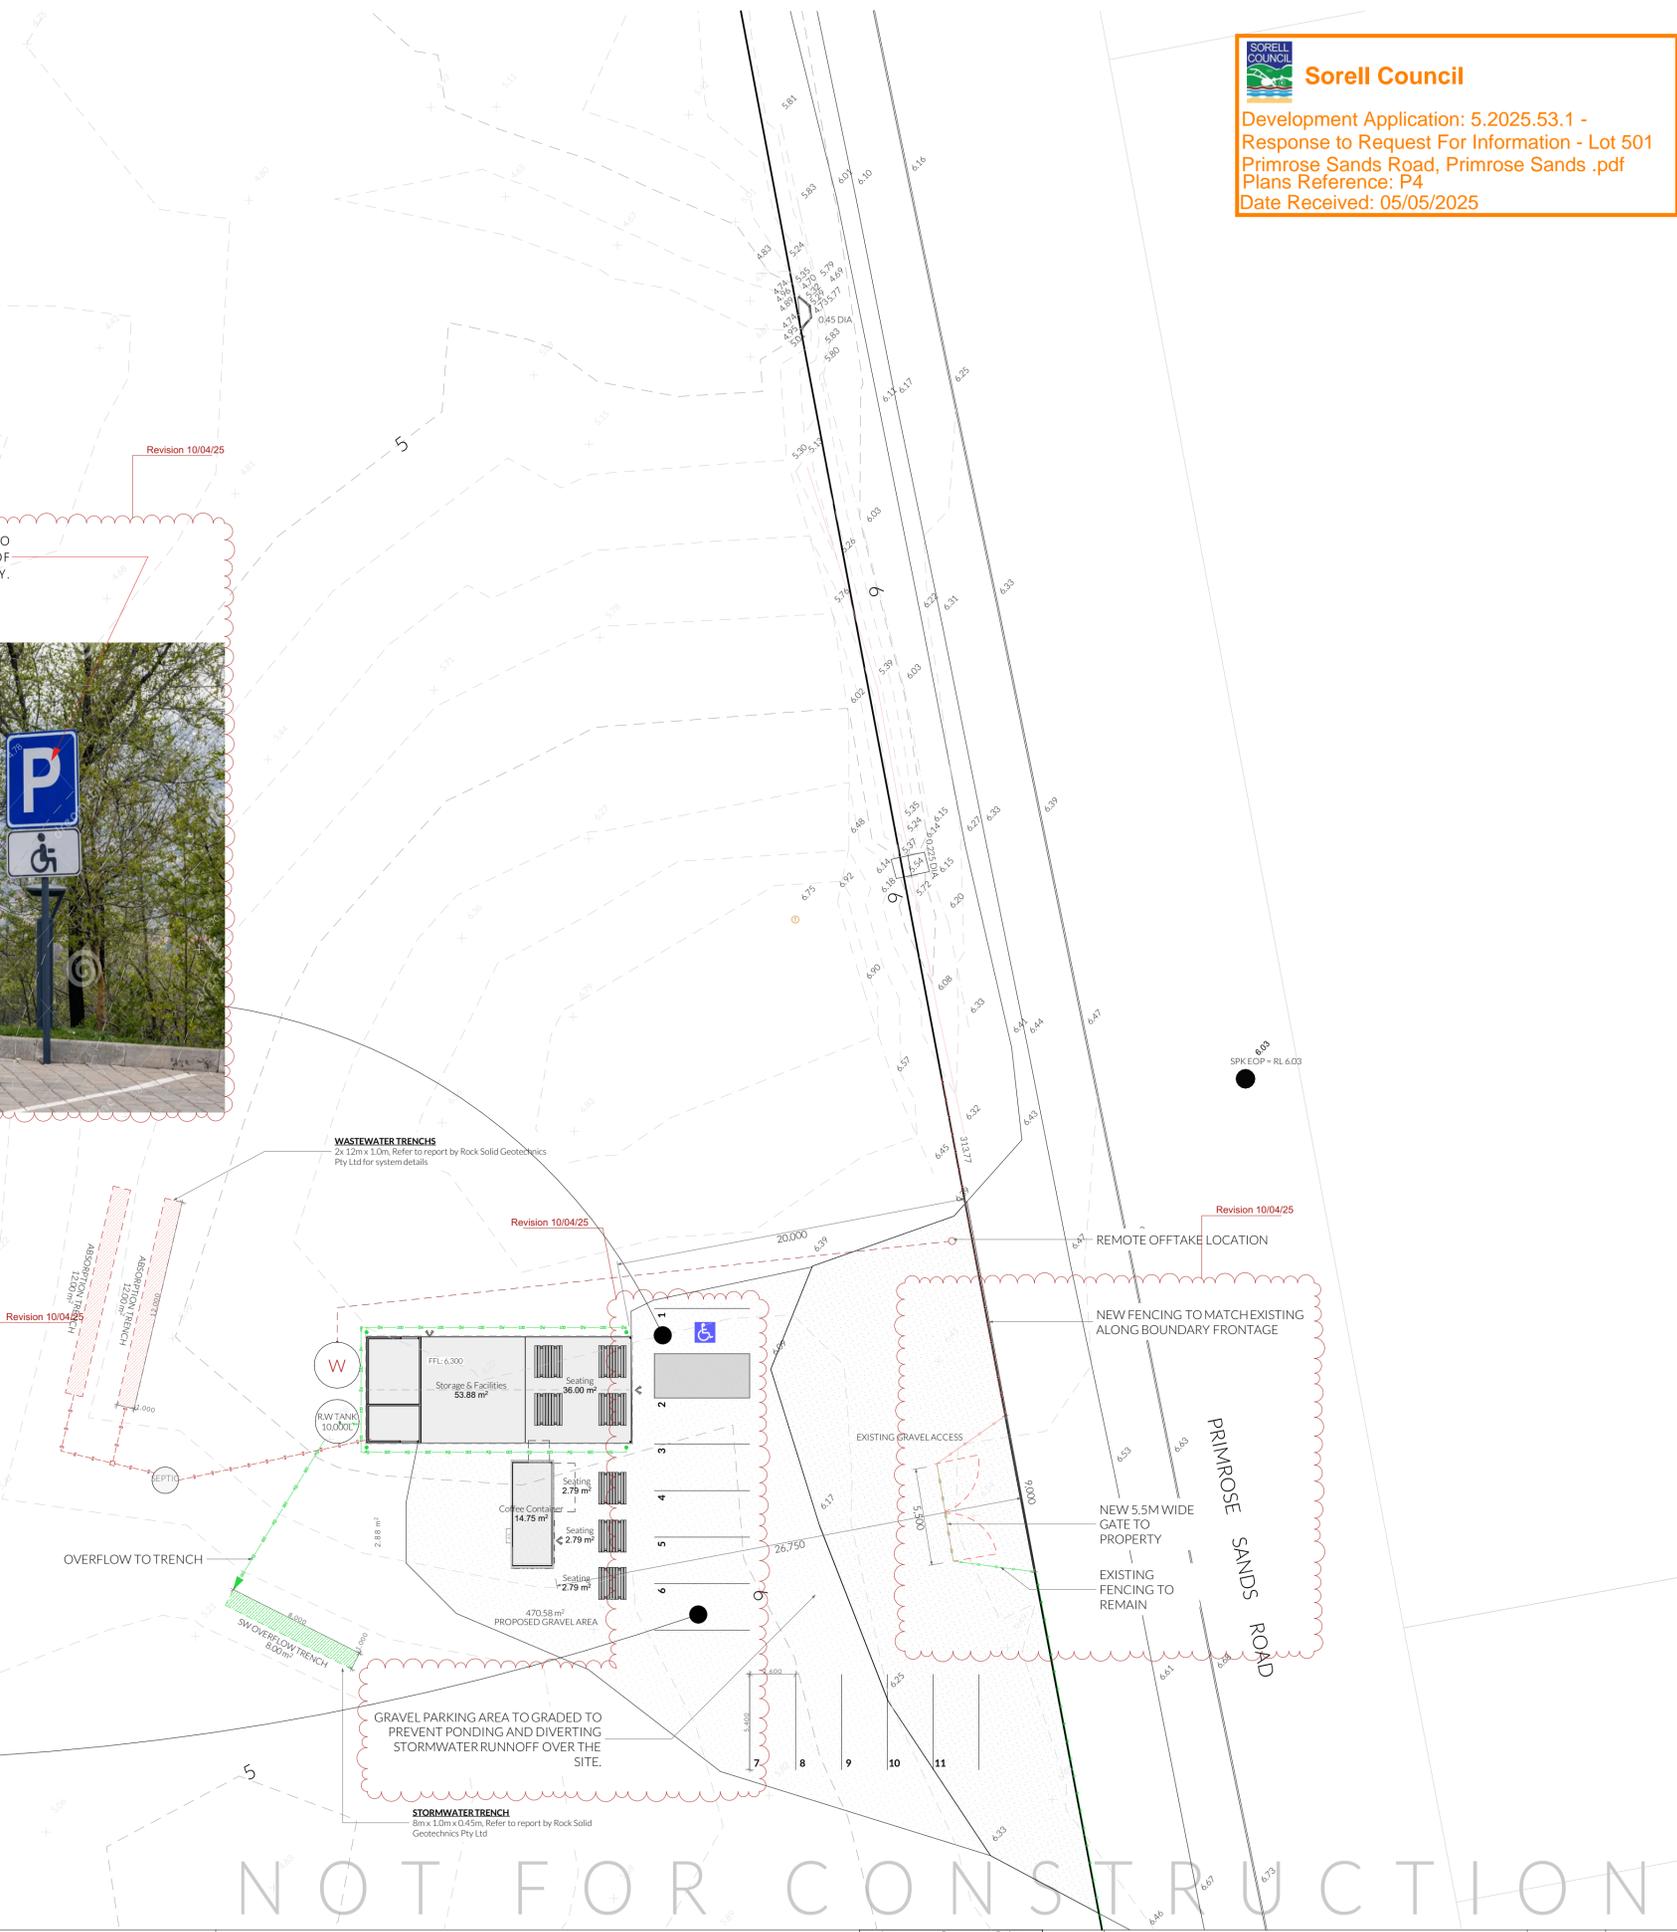
Building Area

Seating	44.37
Coffee Container	14.75
Storage & Facilities	53.88
113.00 m²

501
 115400m²
 CT: 17783/501
