# NOTICE OF PROPOSED DEVELOPMENT

**SITE: 6 Sunningdale Close, Midway Point**

**PROPOSED DEVELOPMENT:  
DWELLING AND OUTBUILDING**

AP2025-2456 - PROPOSED BURGESS & JOHNSTONE (1998) RESIDENCE  
6 Sunningdale Close,  
MIDWAY POINT

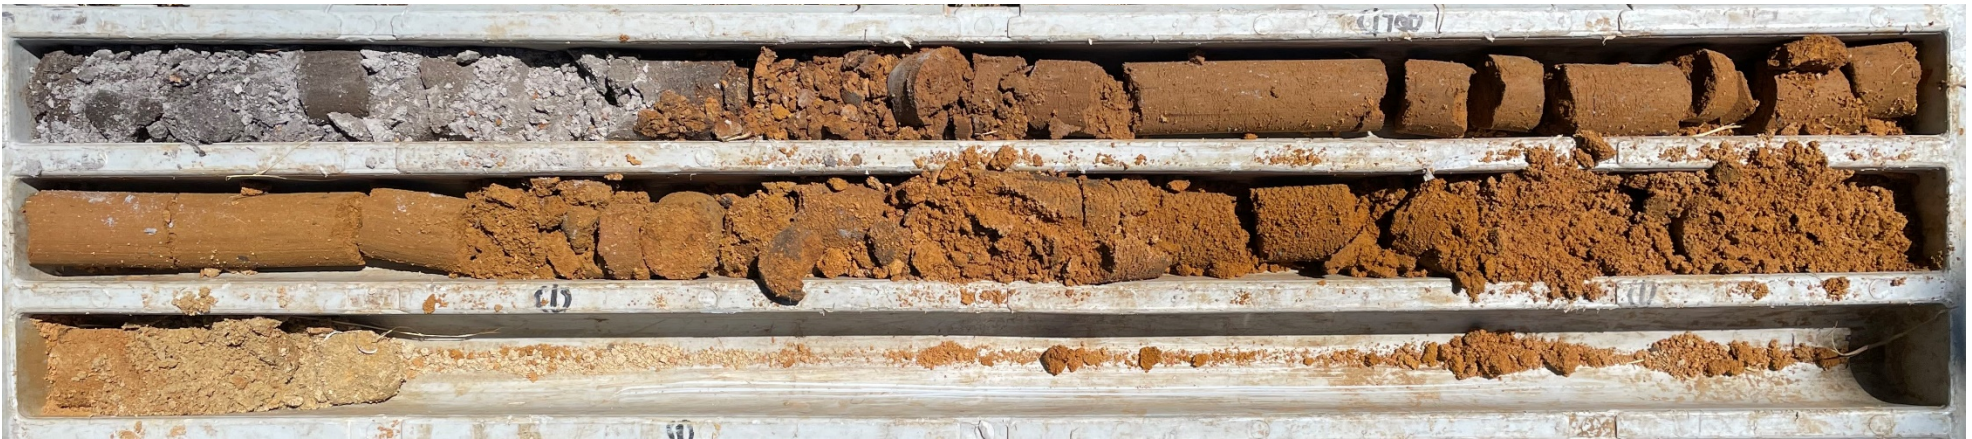
### BH02

\* 1 metre core tray length
