SITE:**62 FRIENDSHIP DRIVE, SORELL****PROPOSED DEVELOPMENT:****DWELLING**

Full description of Proposal:	Use: Dwelling
	Development: Construction of a single dwelling
	<i>Large or complex proposals should be described in a letter or planning report.</i>
Design and construction cost of proposal:	\$ 350,000.00

SITE AND SOIL EVALUATION REPORT **FOUNDATION AND WINDLOADING ASSESSMENT**

62 (Lot 321) Friendship Drive

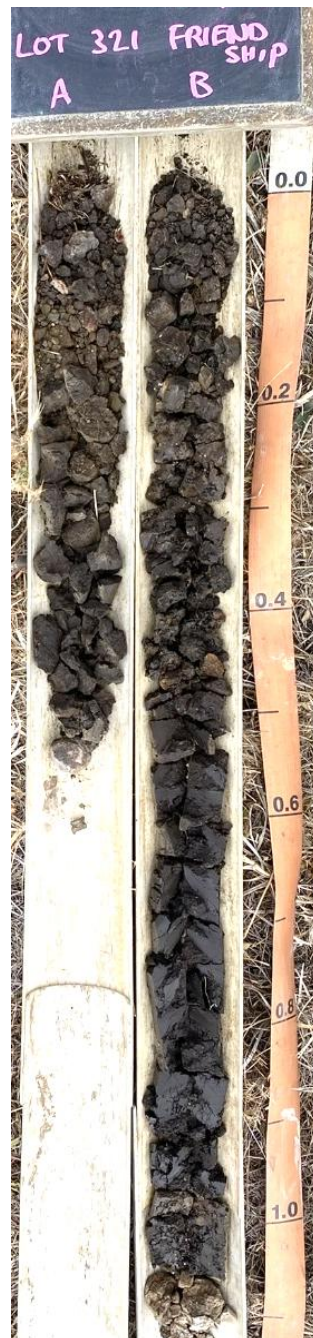
SOIL PROFILES – Test Hole 1 and 2

Depth (m) TH-A	Depth (m) TH-B	Horizon	Description and field texture grade	USCS Class
0 – 0.2	0 – 0.5	FILL	Uncontrolled, dominantly local highly reactive clay FILL	CH
0.2 – 0.5	0.5 – 1.1	B1/B2	Black (10YR 2/1), Silty Medium Clay , massive/compacted grading to moderate coarse angular blocky at depth, dry hard grading to slightly moist stiff to hard consistency Refusal on basalt bedrock.	CH

Layers of uncontrolled local highly reactive clay fill are present on the site to maximum observed depths of 0.2 to 0.5 m.

The *natural* soil profiles (excluding fill and disturbed materials) are formed from clayey colluvium derived from Tertiary basalt. The profiles are moderately deep with refusal occurring at approximately 0.5 to 1.1 m. The field textures of the soil profile are dominated by clay, which is highly reactive, weakly structured and mildly dispersive. The DCP indicates a low bearing capacity to at least 0.6 m. Founding on the underlying, highly competent, basalt bedrock, at approximately 0.5 to 1.1 m depth, is recommended.
