# NOTICE OF PROPOSED DEVELOPMENT

**SITE:****64 FRIENDSHIP DRIVE, SORELL****PROPOSED DEVELOPMENT:****DWELLING**

## **SITE AND SOIL EVALUATION REPORT** **FOUNDATION AND WINDLOADING ASSESSMENT**

**64 (Lot 322) Friendship Drive**

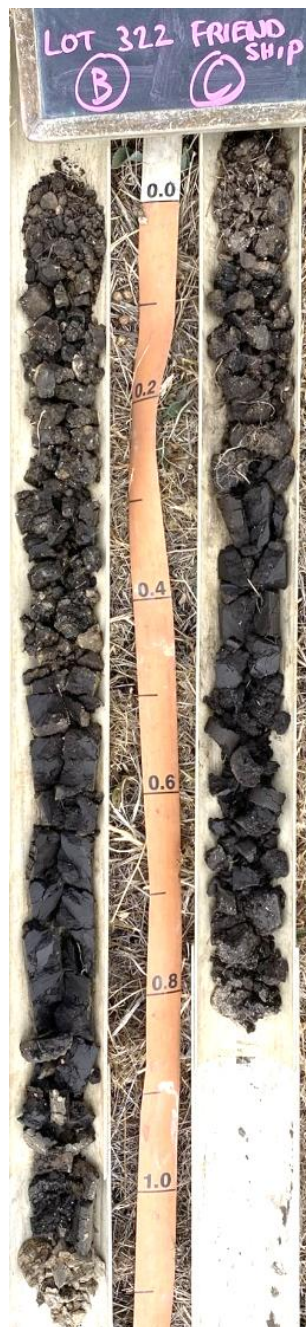
| Depth (m) TH-B | Depth (m) TH-C | Horizon | Description and field texture grade | USCS Class |
|---|---|---|---|---|
| 0 – 0.5 | 0 – 0.2 | FILL | Uncontrolled, dominantly local highly reactive clay <b>FILL</b> | <b>CH</b> |
| 0.5 – 1.1 | 0.2 – 0.8 | B1/B2 | Black (10YR 2/1), <b>Silty Medium Clay</b> , massive/compacted grading to weak coarse angular blocky at depth, dry hard grading to slightly moist stiff to hard consistency.<br><br>Refusal on basalt bedrock. | <b>CH</b> |

- Two test hole (TH) cores:
  - TH1 (B) with refusal at 1.1 m
  - TH2 (C) with refusal at 0.8 m
- One Dynamic Cone Penetrometer (DCP) test:
  - DCP1 with refusal at 0.9 m
- Emerson Dispersion test on subsoils and linear shrinkage tests on all likely founding layers.

## SITE AND SOIL COMMENTS

Layers of uncontrolled local highly reactive clay fill are present on the site to maximum observed depths of 0.2 to 0.5 m.

The *natural* soil profiles (excluding fill and disturbed materials) are formed from clayey colluvium derived from Tertiary basalt. The profiles are moderately deep with refusal occurring at approximately 0.8 to 1.1 m. The field textures of the soil profile are dominated by clay, which is highly reactive, weakly structured and mildly dispersive. The DCP indicates a low bearing capacity to at least 0.7 m. Founding on the underlying, highly competent, basalt bedrock, at approximately 0.8 to 1.1 m depth, is recommended.
