BUSHFIRE ASSESSMENT REPORT

Proposed Subdivision (2 lots)

Address: 5 Cherry Court, Forcett TAS 7173

GEOTECHNICAL SITE INVESTIGATION

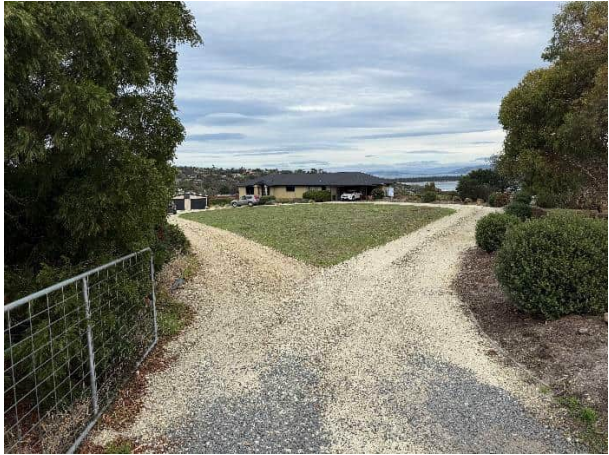
Figure 5 – Existing access loop for Lot 1

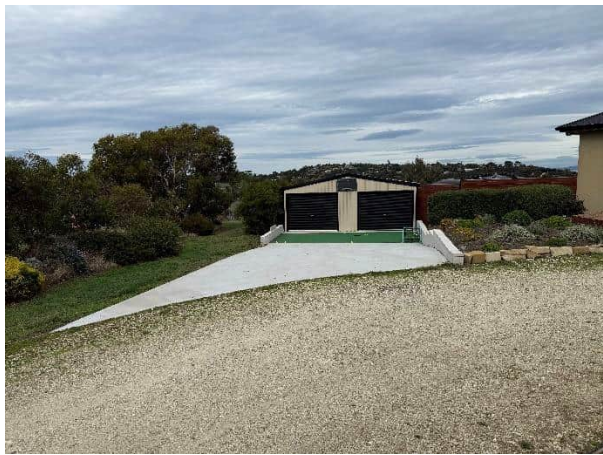
Figure 5.1 – Existing parking/turning area for Lot 1

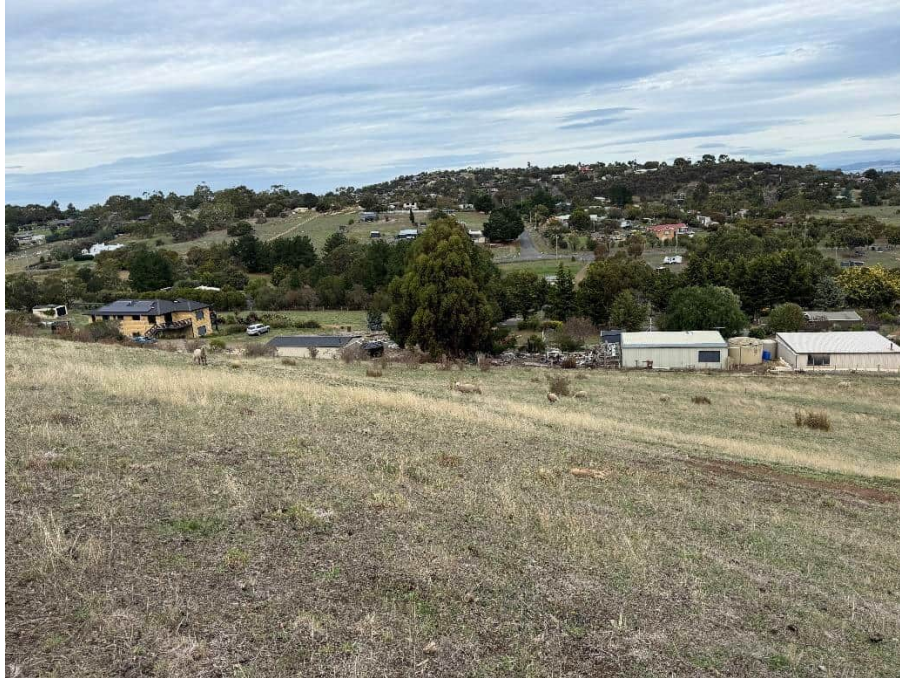
Figure 6 – Grassland fuel in Lot 2, managed land in the background, view facing SW

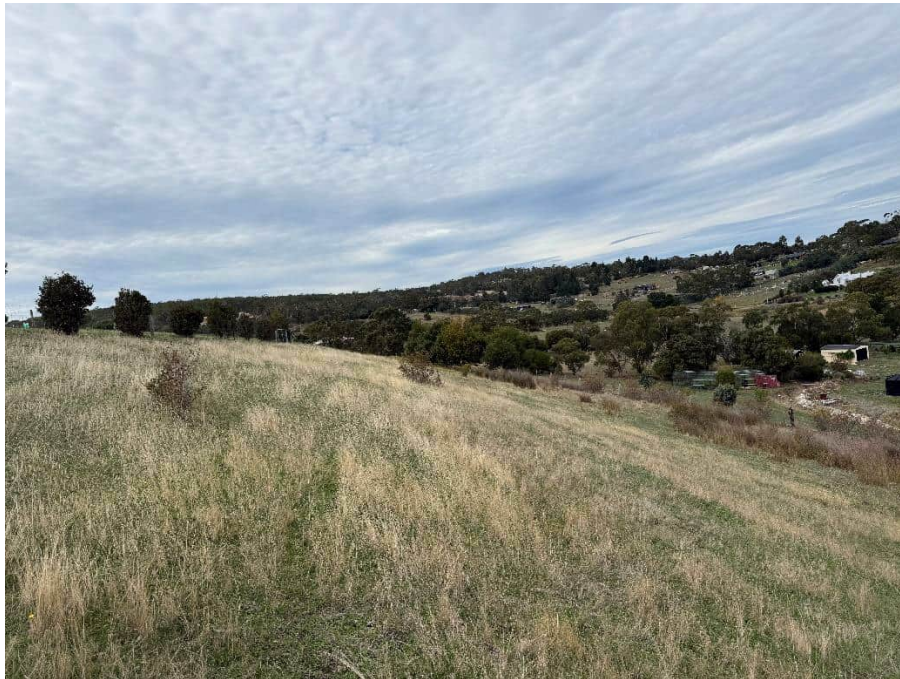
Figure 7 – Grassland fuel within Lot 2, view facing E, SE

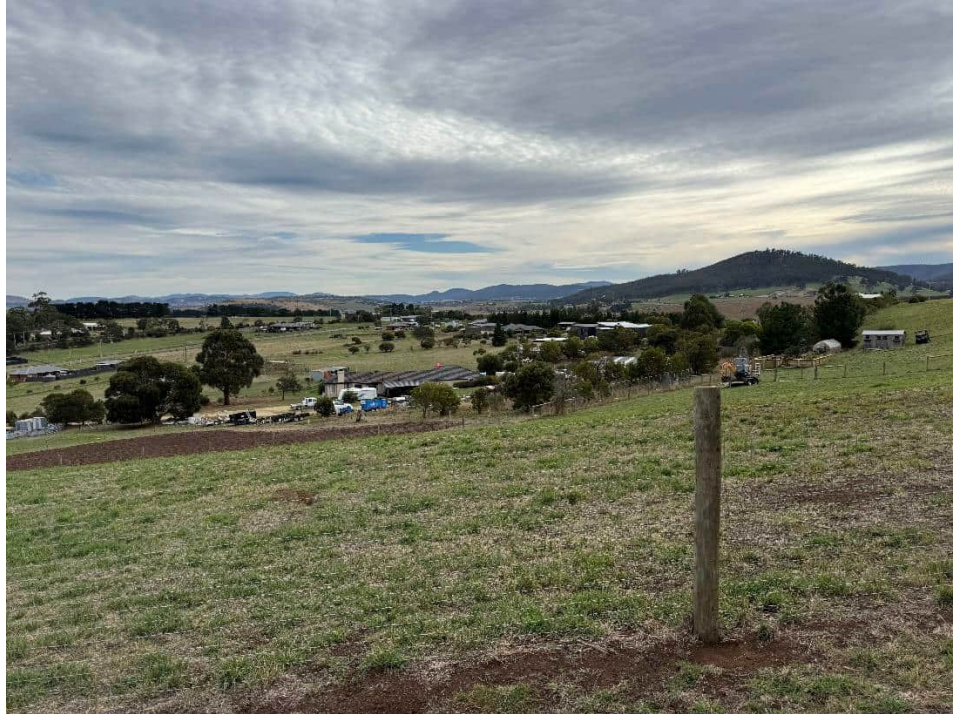
Figure 8 – Grassland fuel to the west of the property, view facing W, NW

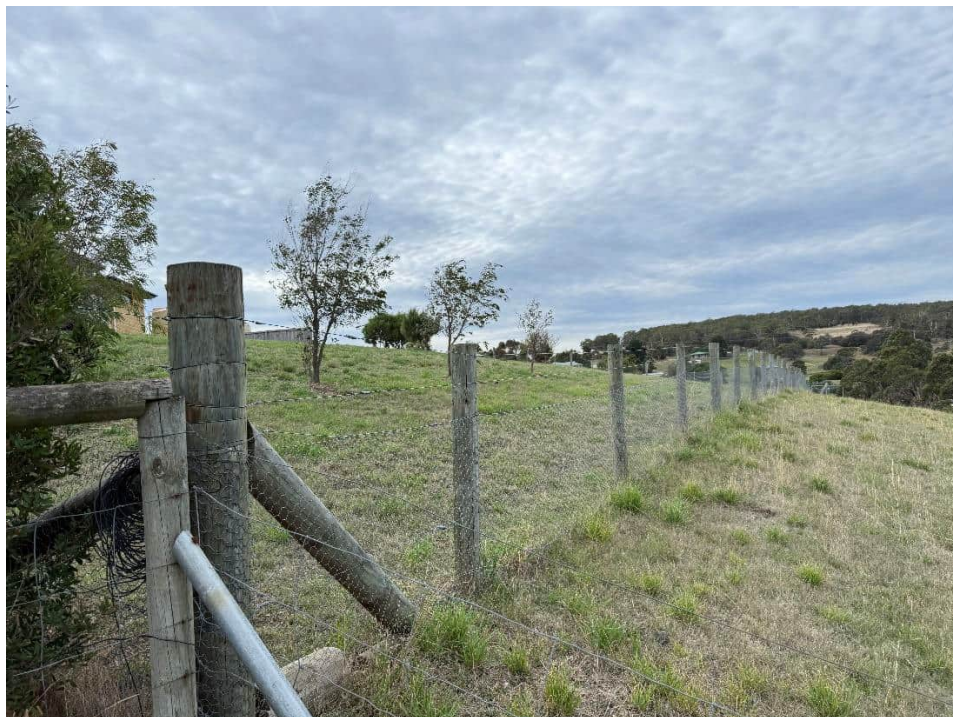
Figure 9 – Grassland fuel east of the property, view facing E

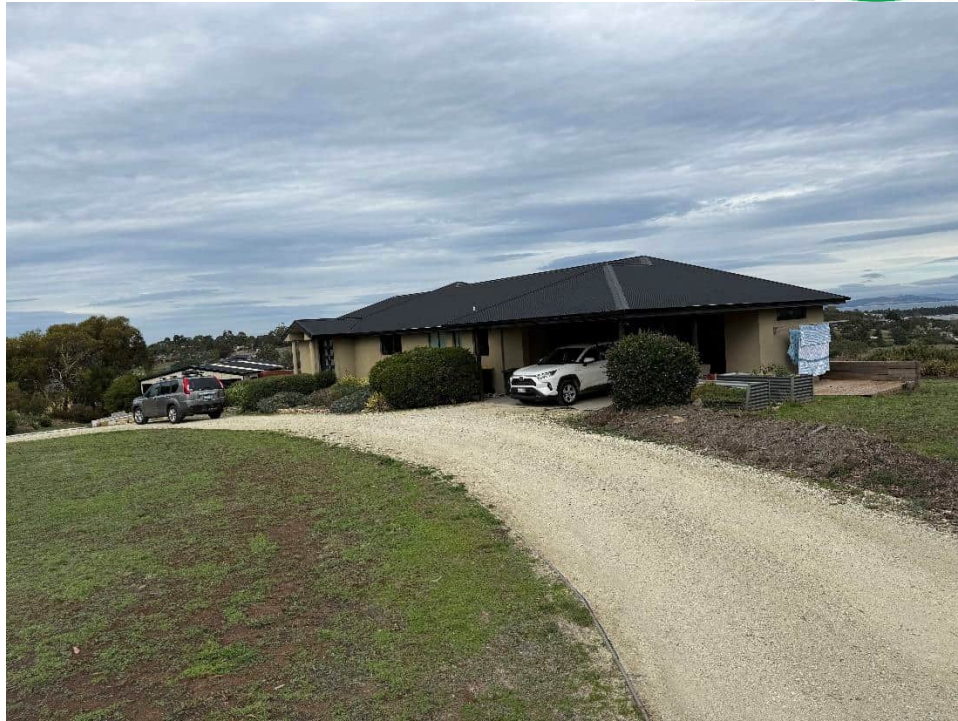
Figure 10 – Existing managed land and dwelling in Lot 1, view facing S

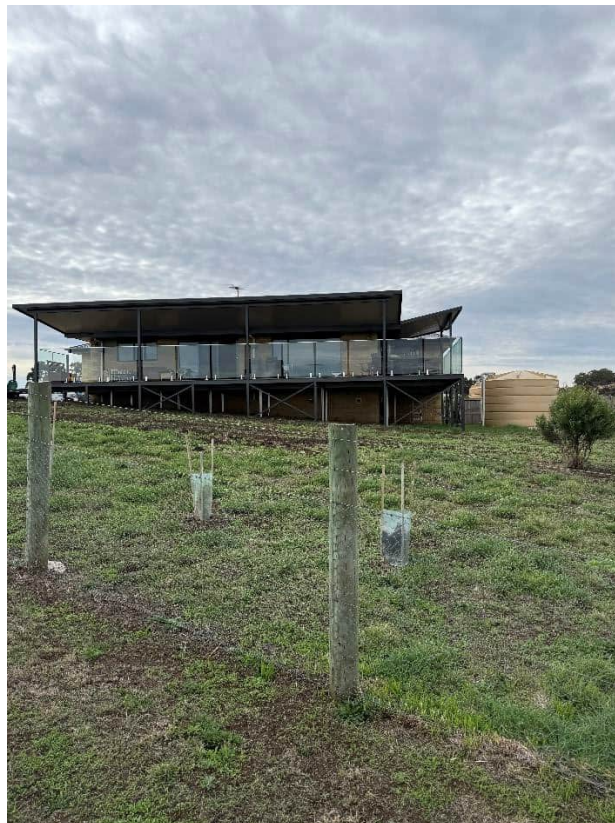
Figure 11 – Existing dwelling and managed land to the east of the property, view facing E, NE

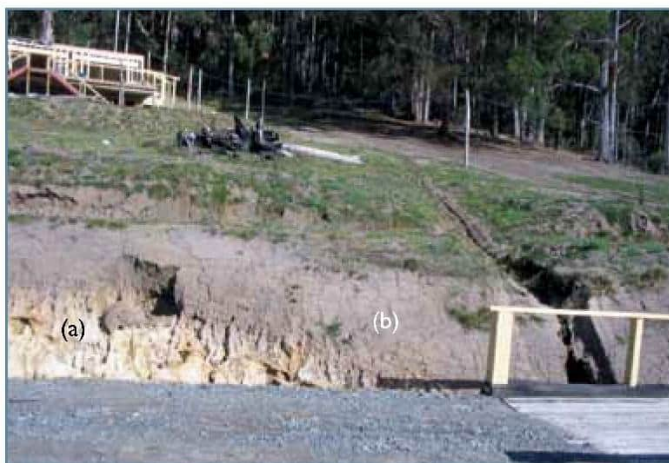
Figure 13. The severity (or sodium content) and depth of dispersive subsoils can vary considerably over short distances. (a). At this site highly dispersive subsoils exist meters away from (b) non-dispersive soils.

The risk of tunnel erosion resulting from construction activities on dispersive soils can often be reduced or eliminated by identifying and avoiding areas containing dispersive soils. The presence and severity of dispersive soils can vary enormously over short distances (Figure 13). In many instances, large scale (ie 10 x 10 or 20 x 20 meter grid) soil survey and screening of soils for dispersion, (using the Emerson crumb test - section 3, Appendix I) can be used to site dwellings and infrastructure away from dispersive soils. Advice should be sought from a suitably qualified and experienced engineer or soil professional.

Figure 13. The severity (or sodium content) and depth of dispersive subsoils can vary considerably over short distances. (a). At this site highly dispersive subsoils exist meters away from (b) non-dispersive soils.

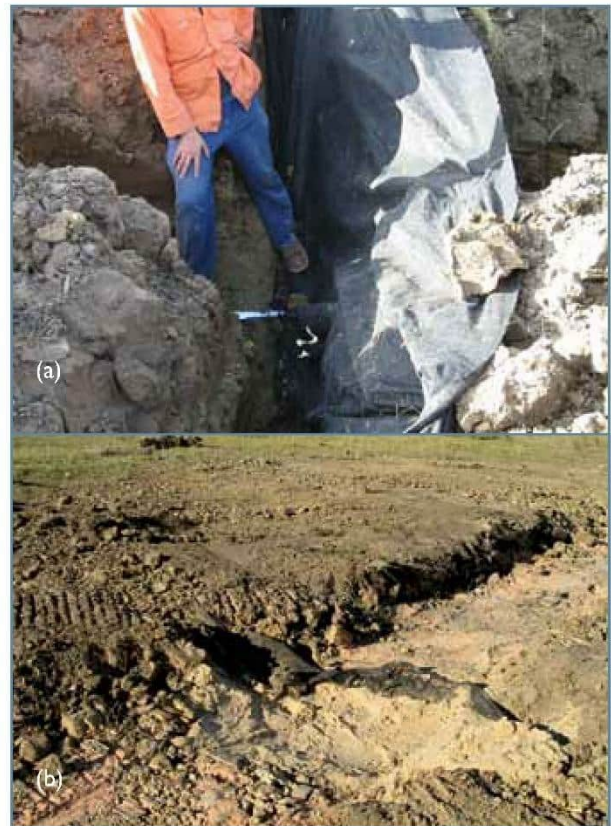
Figure 15. (a) Installation of sandblock perpendicular to a service trench. Note securing of geotextile to the optical fibre cable to prevent water flowing past the sand block. (b) Sandblock before final topsoiling.

Sand filters were first developed to prevent piping in earth dams. Sand filters prevent dam failure by trapping entrained sand and silt, blocking the exit of the tunnel and preventing further tunnel development (Sherard *et al.* 1977). Following the work of Sherard *et al.* (1977), Richley (1992 and 2000) developed the use of sand blocks to prevent tunnel erosion during installation of an optical fibre cable in highly dispersive soils near Campania, Tasmania. The sand blocks work slightly differently to the sand filters in that they allow the free water to rise to the surface through the sand. The use of sand blocks has recently been modified by Hardie *et al.*, (2007) to prevent re-initiation of tunnel erosion along an optical fibre cable near Dunalley. Modifications to the original technique developed by Richley (1992 and 2000) include (Figure 14 & 15);

Figure 15. (a) Installation of sandblock perpendicular to a service trench. Note securing of geotextile to the optical fibre cable to prevent water flowing past the sand block. (b) Sandblock before final topsoiling.

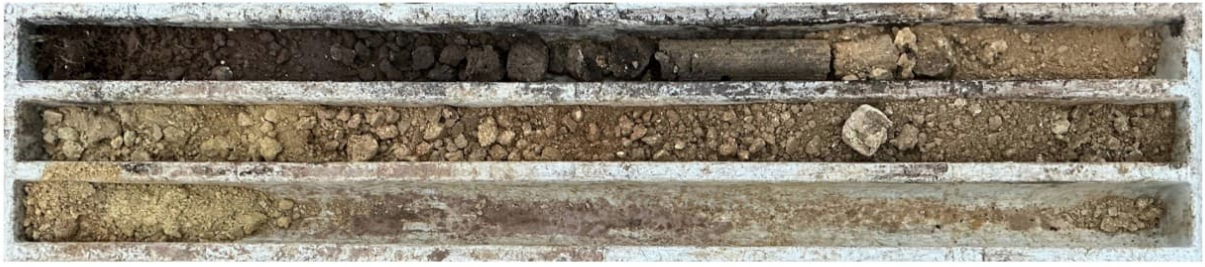
BH01

Figure 5 – Bore Hole Soil Samples

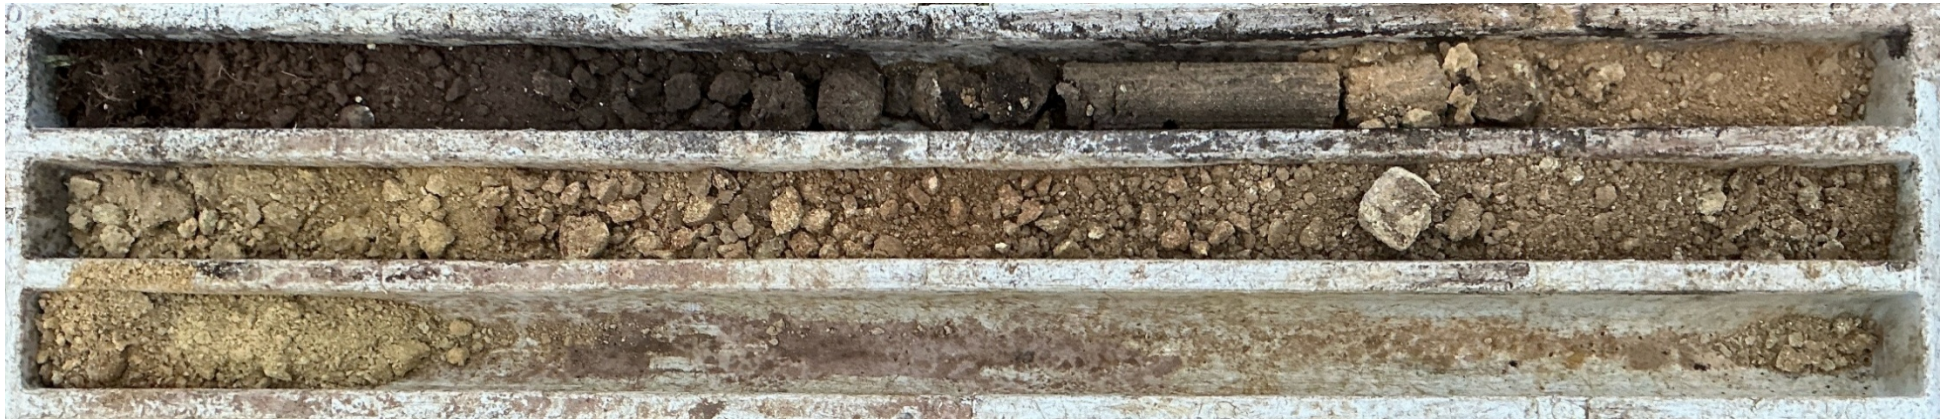
BH01

Appendix D Core Photographs

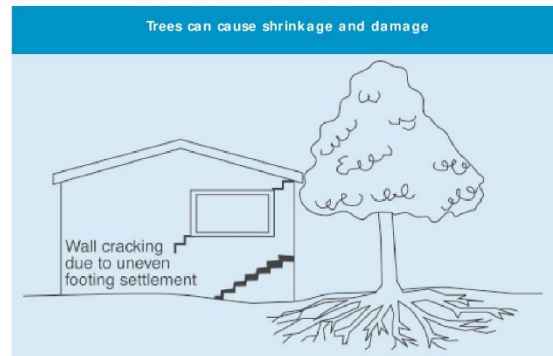
As the moisture absorption process completes its journey to the innermost areas of the building, the internal footings will rise. If the spread of moisture is roughly even, it may be that the symptoms will temporarily disappear, but it is more likely that swelling will be uneven, creating a difference rather than a disappearance in symptoms. In buildings with timber flooring supported by bearers and joists, the isolated piers will rise more easily than the strip footings or piers under walls, creating noticeable doming of flooring.

As the weather pattern changes and the soil begins to dry out, the external footings will be first affected, beginning with the locations where the sun's effect is strongest. This has the effect of lowering the external footings. The doming is accentuated and cracking reduces or disappears where it occurred because of dishing, but other cracks open up. The roof lines may become convex.

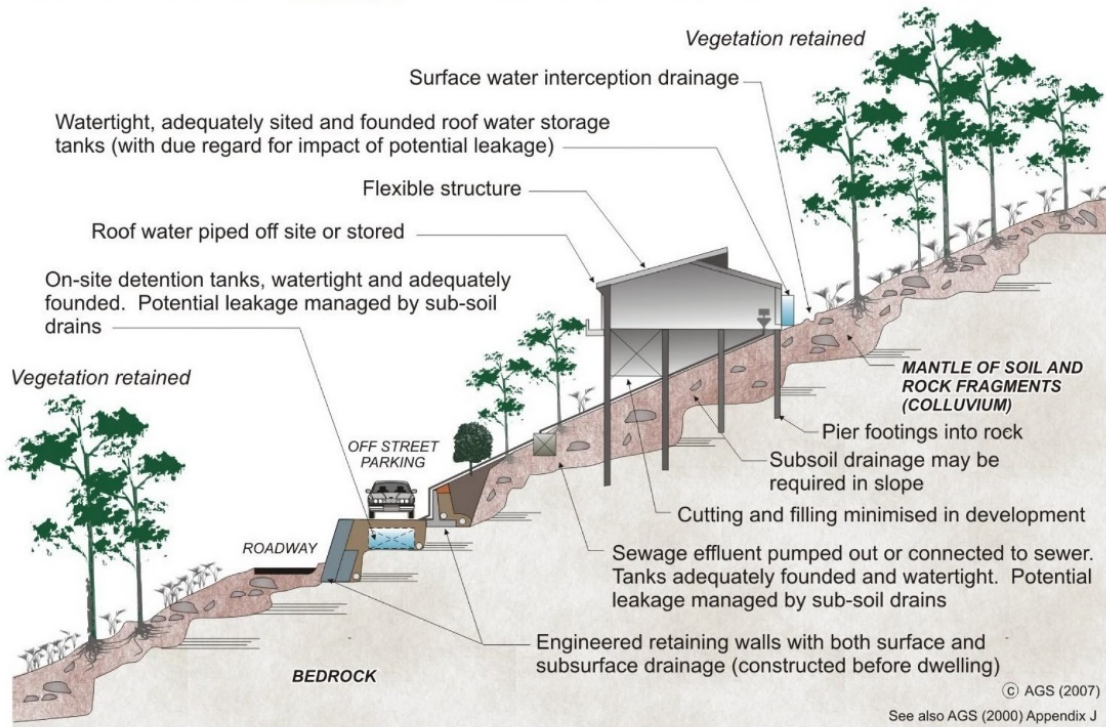
EXAMPLES OF GOOD HILLSIDE CONSTRUCTION PRACTICE

Sensible development practices are required when building on hillsides, particularly if the hillside has more than a low risk of instability (GeoGuide LR7). Only building techniques intended to maintain, or reduce, the overall level of landslide risk should be considered. Examples of good hillside construction practice are illustrated below.

Roadways and parking areas - are paved and incorporate kerbs which prevent water discharging straight into the hillside (GeoGuide LR5).

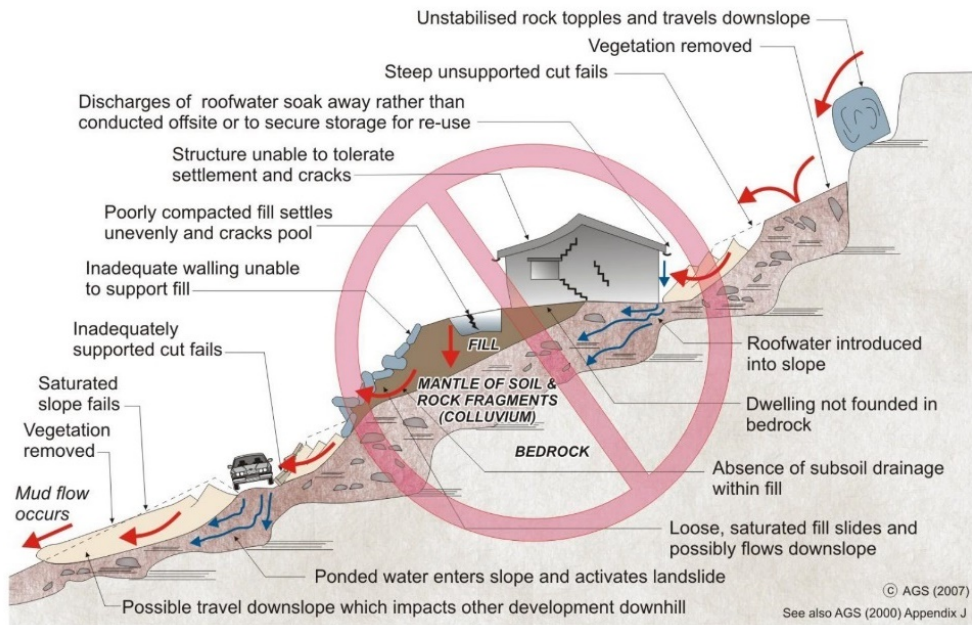
EXAMPLES OF **POOR** HILLSIDE CONSTRUCTION PRACTICE

Roadways and parking areas - are unsurfaced and lack proper table drains (gutters) causing surface water to pond and soak into the ground.
